ARCHITECH

HOME INSPECTION SYSTEMS, LLC

123 Anykine Dr, Honolulu , Hawaii 96888

Inspection Date:
11/12/2008
Prepared For:
Ver E. Important
Report Number:
20081014-BN-1
Inspector:
Bryan Naff

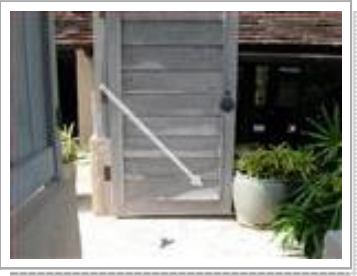
Figure Number 1

Minor repairs may be required at several gates; loose panels, binding latches, weather damage noted. Repair as needed. (See Figure #1) (See Figure #2) (See Figure #3) (See Figure #4)

Minor repairs may be required at several gates; loose panels, binding latches, weather damage noted. Repair as needed.

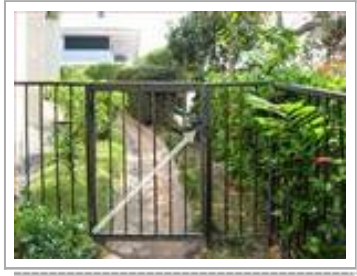
Figure Number 2

Minor repairs may be required at several gates; loose panels, binding latches, weather damage noted. Repair as needed.

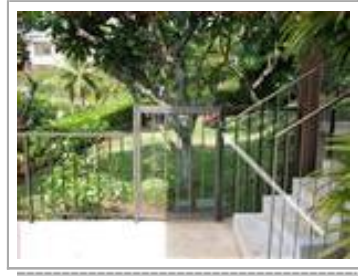
Figure Number 3

Minor repairs may be required at several gates; loose panels, binding latches, weather damage noted. Repair as needed.

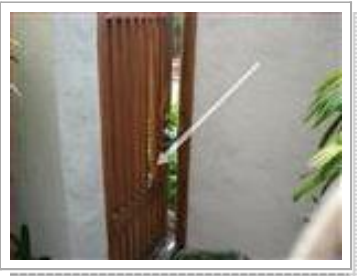
Figure Number 4

Minor repairs may be required at several gates; loose panels, binding latches, weather damage noted. Repair as needed.

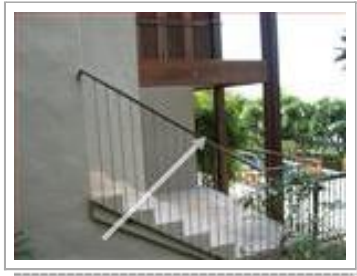
Figure Number 5

Rail caps at right side rear stair are separating from rail. Recommend repairs as needed. (See Figure #5)

Rail caps at right side rear stair are separating from rail. Recommend repairs as needed.

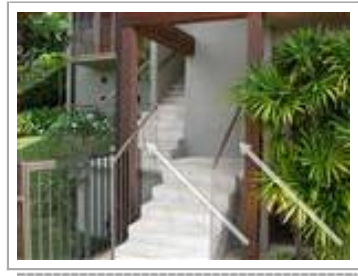
Figure Number 6

Appears the design of the balustrades at the rear right stair creates an inherent instability in the rail. Recommend stabilize as needed. (See Figure #6)

Appears the design of the balustrades at the rear right stair creates an inherent instability in the rail. Recommend stabilize as needed.

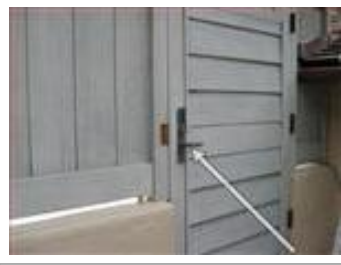
Figure Number 7

Noted lockset at front entry gate in need of minor adjustments/repairs; loose at handle. (See Figure #7)

Noted lockset at front entry gate in need of minor adjustments/repairs; loose at handle.

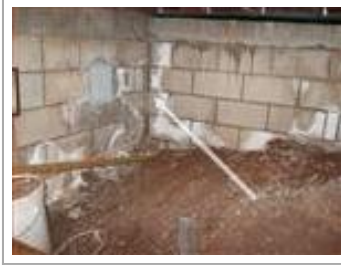
Figure Number 8

Noted efflorescence (white powdery substance) at walls in crawlspace. May indicate migration of moisture through masonry walls. Recommend clean, monitor and repairs as needed. (See Figure #8) (See Figure #9) (See Figure #10)

Noted efflorescence (white powdery substance) at walls in crawlspace. May indicate migration of moisture through masonry walls. Recommend clean, monitor and repairs as needed.

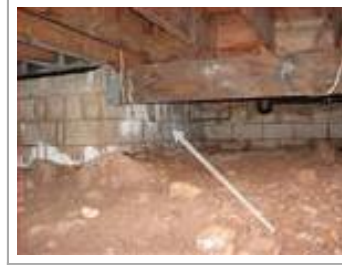
Figure Number 9

Noted efflorescence (white powdery substance) at walls in crawlspace. May indicate migration of moisture through masonry walls. Recommend clean, monitor and repairs as needed.

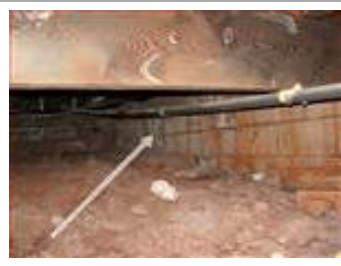
Figure Number 10

Noted efflorescence (white powdery substance) at walls in crawlspace. May indicate migration of moisture through masonry walls. Recommend clean, monitor and repairs as needed.

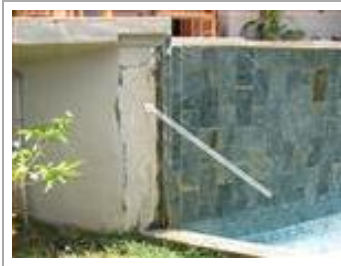
Figure Number 11

Noted minor cracking and signs of efflorescence at sides of infinity pool walls. Recommend clean and monitor for repair as needed. (See Figure #11) (See Figure #12)

Noted minor cracking and signs of efflorescence at sides of infinity pool walls. Recommend clean and monitor for repair as needed.

Remarks	<ol style="list-style-type: none"> 1. Noted minor cracking and signs of efflorescence at sides of infinity pool walls. Recommend clean and monitor for repair as needed. (See Figure #11) (See Figure #12) 2. See Summary Remarks

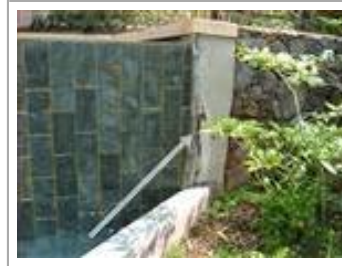
Figure Number 12

Noted minor cracking and signs of efflorescence at sides of infinity pool walls. Recommend clean and monitor for repair as needed.

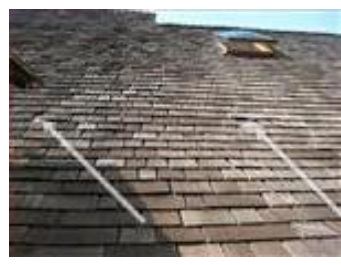
Figure Number 13

Missing shingles noted on various areas of roof. Repair/replace as needed. (See Figure #13) (See Figure #14)

Missing shingles noted on various areas of roof. Repair/replace as needed.

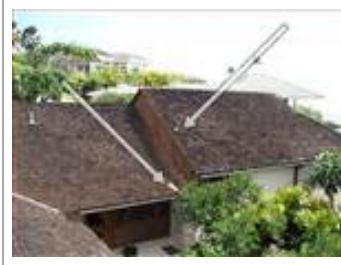
Figure Number 14

Missing shingles noted on various areas of roof. Repair/replace as needed.

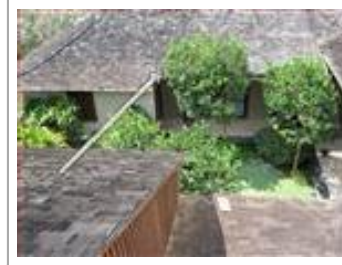
Figure Number 15

Noted tree branches in contact with roof. Recommend trimming tree from roof edge to extend roof life. (See Figure #15) (See Figure #16)

Noted tree branches in contact with roof. Recommend trimming tree from roof edge to extend roof life.

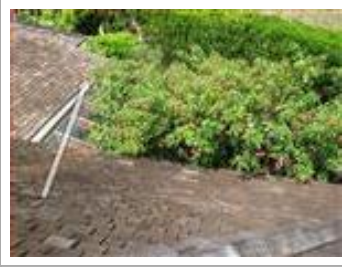
Figure Number 16

Noted tree branches in contact with roof. Recommend trimming tree from roof edge to extend roof life.

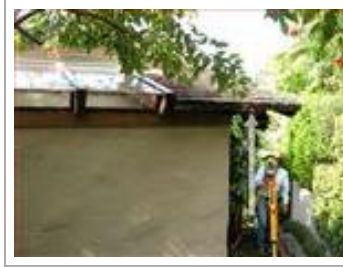
Figure Number 17

Low level moisture stains noted (21%) on wood eaves at right exterior eave. Recommend refinish to extend wood life. (See Figure #17)

Low level moisture stains noted (21%) on wood eaves at right exterior eave. Recommend refinish to extend wood life.

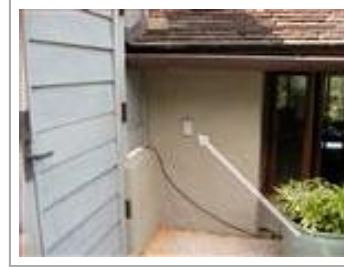
Figure Number 18

Unable to verify operation of switch at front right. Recommend verify with seller. (See Figure #18)

Unable to verify operation of switch at front right. Recommend verify with seller.

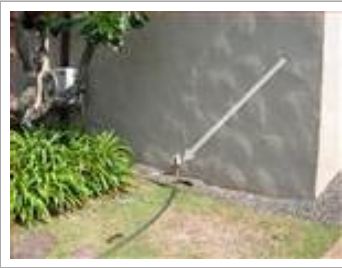
Figure Number 19

Receptacle at middle left exposed conductors and separating from wall. Recommend repairs by qualified electrician as needed. (See Figure #19)

Receptacle at middle left exposed conductors and separating from wall. Recommend repairs by qualified electrician as needed.

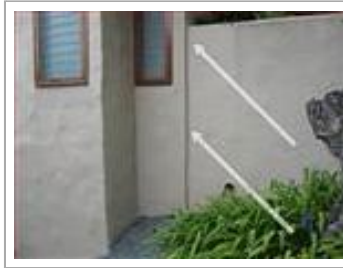
Figure Number 20

Minor separation noted at wall and structure at left middle of exterior. Recommend repairs as needed and monitor. (See Figure #20)

Minor separation noted at wall and structure at left middle of exterior. Recommend repairs as needed and monitor.

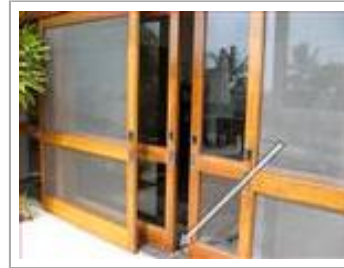
Figure Number 21

Minor adjustment/repairs may be required at sliding doors at pool. (See Figure #21)

Minor adjustment/repairs may be required at sliding doors at pool.

Remarks	<ol style="list-style-type: none"> 1. Minor adjustment/repairs may be required at sliding doors at pool. (See Figure #21) 2. See Summary Remarks

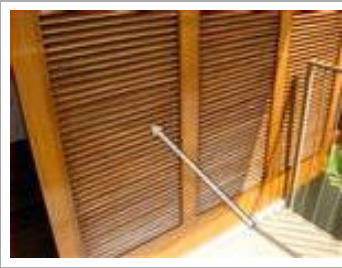
Figure Number 22

Recommend refinish exterior lanai doors of master bedroom to extend life of wood. (See Figure #22)

Recommend refinish exterior lanai doors of master bedroom to extend life of wood.

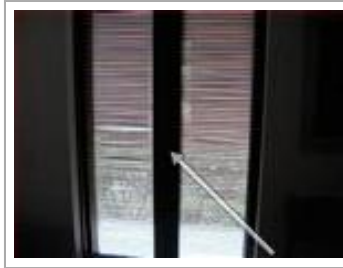
Figure Number 23

Unable to open/operate lockset of lanai doors of 2nd bedroom. Recommend minor adjustments as needed to operate. (See Figure #23)

Unable to open/operate lockset of lanai doors of 2nd bedroom. Recommend minor adjustments as needed to operate.

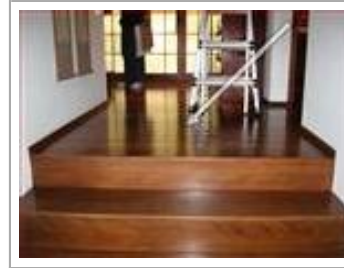
Figure Number 24

Noted minor cupping at wood floor planks at front entry. No active moisture noted. Recommend repairs as needed. (See Figure #24)

Noted minor cupping at wood floor planks at front entry. No active moisture noted. Recommend repairs as needed.

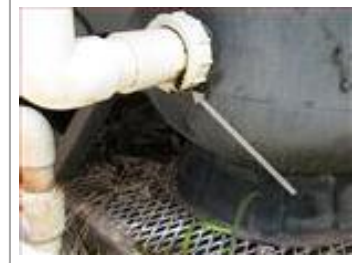
Figure Number 27

Minor water leak/drip noted on connection for pool filter. Repair as needed. (See Figure #27)

Minor water leak/drip noted on connection for pool filter. Repair as needed.

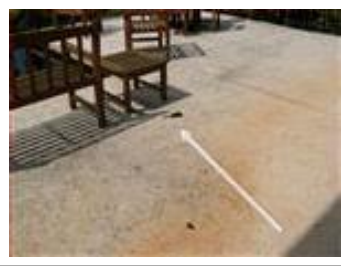
Figure Number 28

Noted hollow sounds at pool deck. Monitor and repair as needed. (See Figure #28)

Noted hollow sounds at pool deck. Monitor and repair as needed.

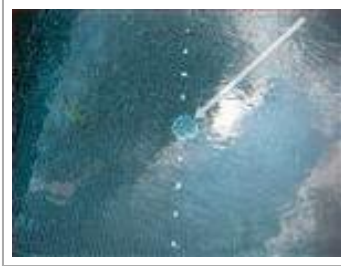
Figure Number 29

Floor return noted at pool. Review possible safety issues regarding this type with pool expert or online. (See Figure #29)

Floor return noted at pool. Review possible safety issues regarding this type with pool expert or online.

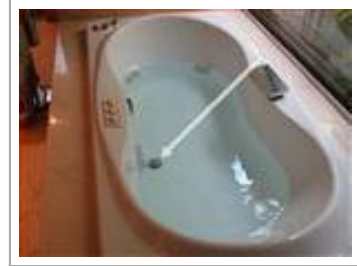
Figure Number 30

Tub in master bath was noisy when drained. Repairs recommended as needed. (See Figure #30)

Tub in master bath was noisy when drained. Repairs recommended as needed.

Remarks	<ol style="list-style-type: none">1. Tub in master bath was noisy when drained. Repairs recommended as needed. (See Figure #30)2. See Summary Remarks
