# ARCHITECH

123 Anykine Dr, Honolulu , Hawaii 96888

**Inspection Date:**  
11/12/2008  
**Prepared For:**  
Ver E. Important  
**Report Number:**  
20081014-BN-1  
**Inspector:**  
Bryan Naff

# Property Analysis Report

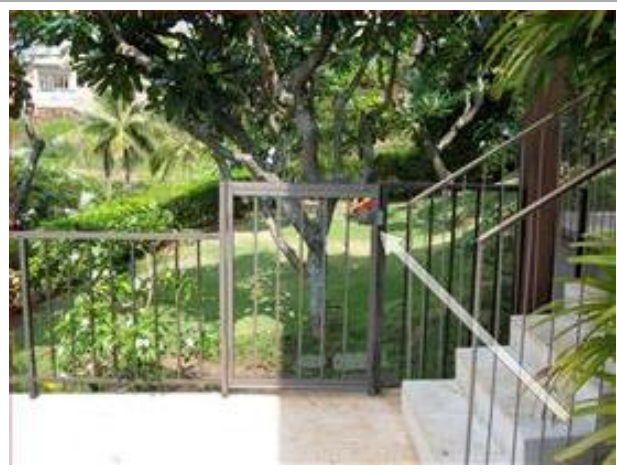
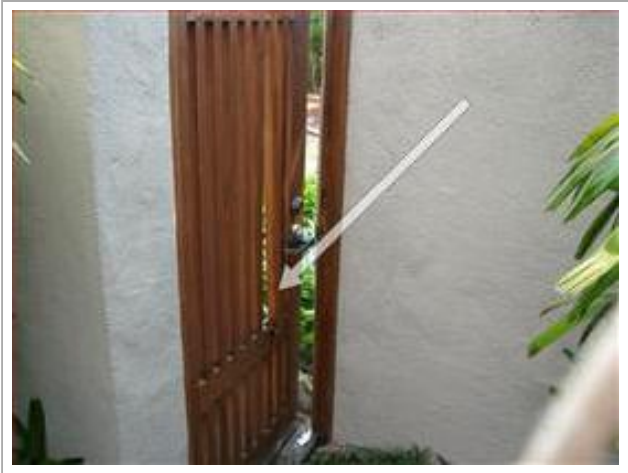
- Minor repairs may be required at several gates; loose panels, binding latches, weather damage noted. Repair as needed. (See Figure #1) (See Figure #2) (See Figure #3) (See Figure #4)

Minor repairs may be required at several gates; loose panels, binding latches, weather damage noted. Repair as needed.

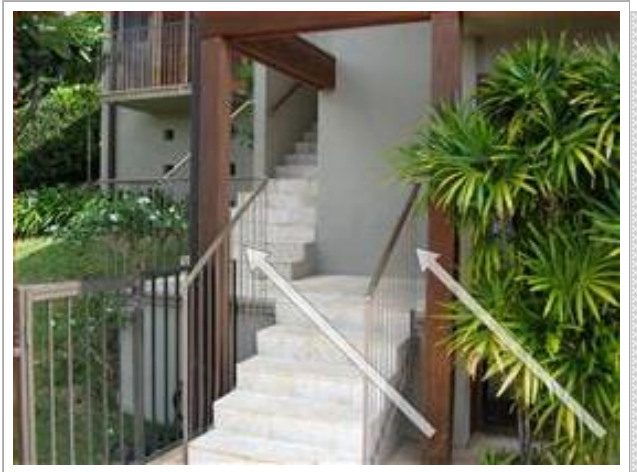
Figure Number 6

Appears the design of the balustrades at the rear right stair creates an inherent instability in the rail. Recommend stabilize as needed.

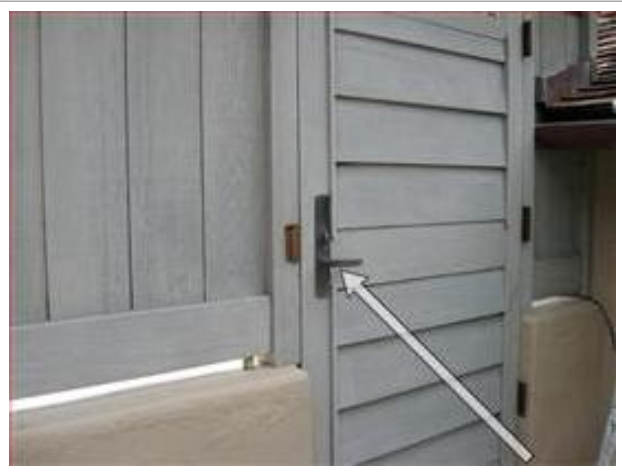
Figure Number 7

Noted lockset at front entry gate in need of minor adjustments/repairs; loose at handle.

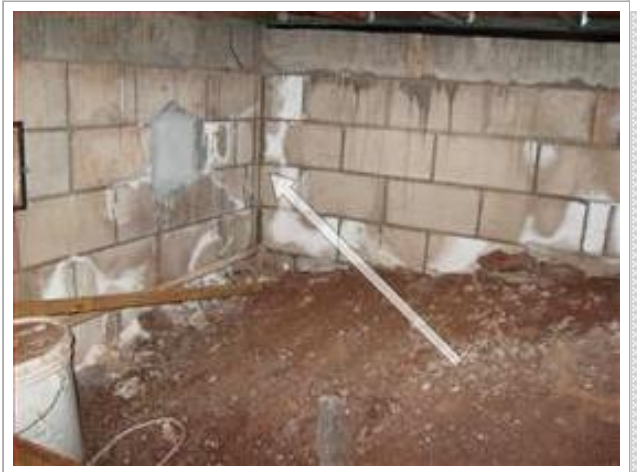
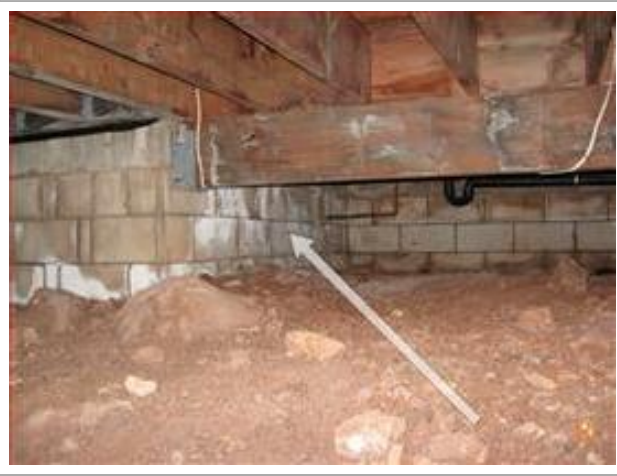
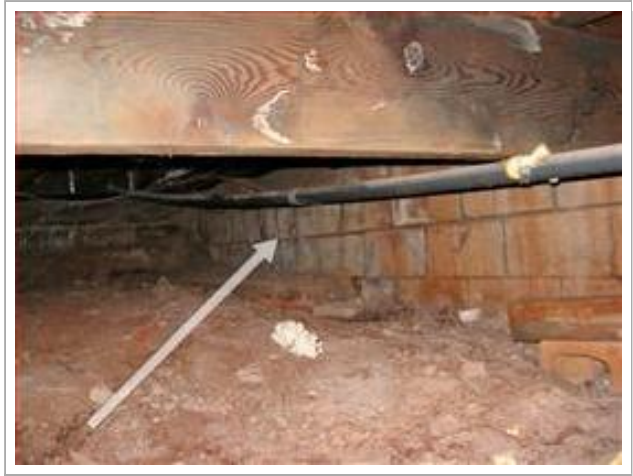
Noted efflorescence (white powdery substance) at walls in crawlspace. May indicate migration of moisture through masonry walls. Recommend clean, monitor and repairs as needed.

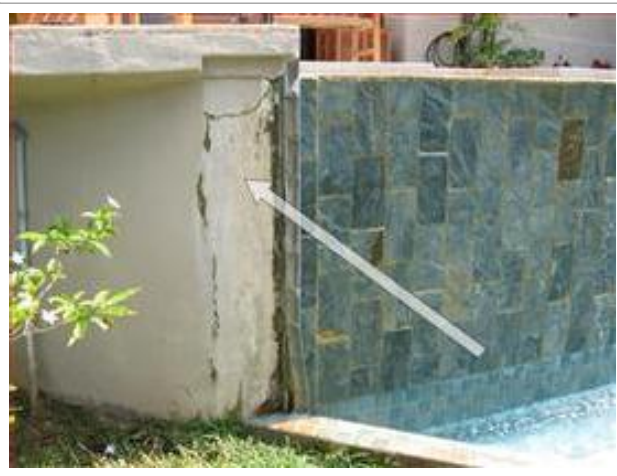
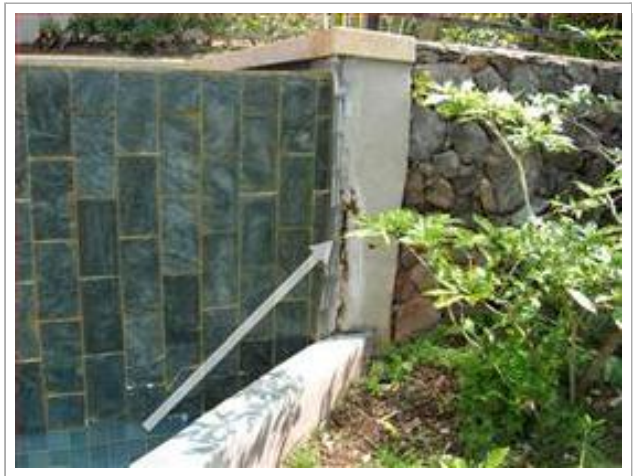
Remarks	<ul style="list-style-type: none"> <li>Noted minor cracking and signs of efflorescence at sides of infinity pool walls. Recommend clean and monitor for repair as needed. (See Figure #11) (See Figure #12)</li> <li>See Summary Remarks</li> </ul>

Noted minor cracking and signs of efflorescence at sides of infinity pool walls. Recommend clean and monitor for repair as needed.

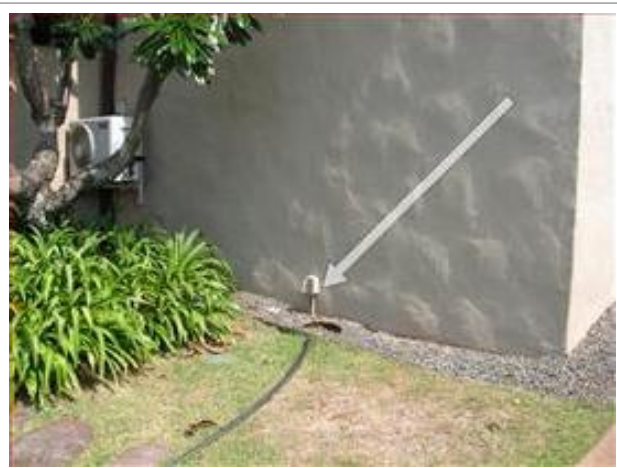
Figure Number 19

Receptacle at middle left exposed conductors and separating from wall. Recommend repairs by qualified electrician as needed.

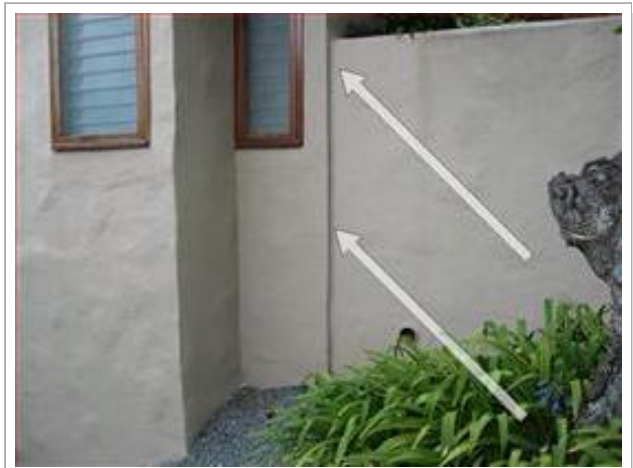
Figure Number 20

Minor separation noted at wall and structure at left middle of exterior. Recommend repairs as needed and monitor.

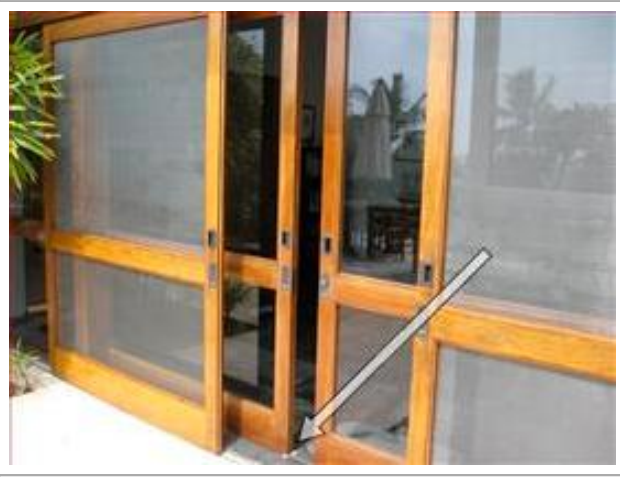
Figure Number 21

Remarks	<ul style="list-style-type: none"> <li>Minor adjustment/repairs may be required at sliding doors at pool. (See Figure #21)</li> <li>See Summary Remarks</li> </ul>

Minor adjustment/repairs may be required at sliding doors at pool.

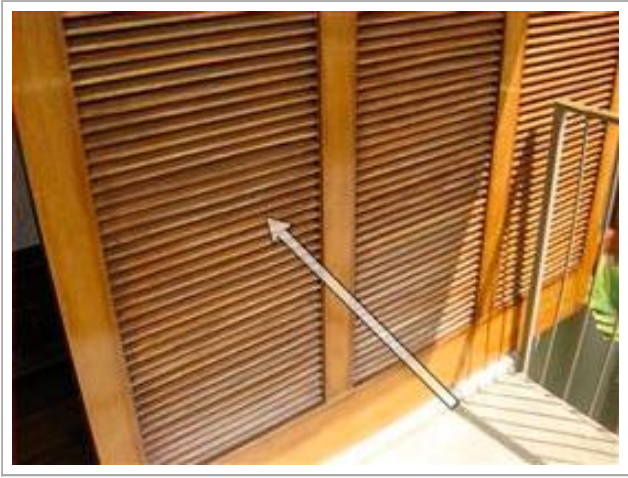
Figure Number 22

Recommend refinish exterior lanai doors of master bedroom to extend life of wood.

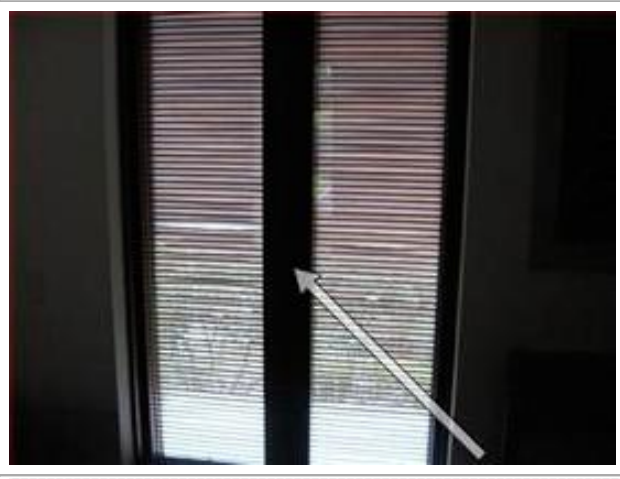
Figure Number 23

Unable to open/operate lockset of lanai doors of 2nd bedroom. Recommend minor adjustments as needed to operate.

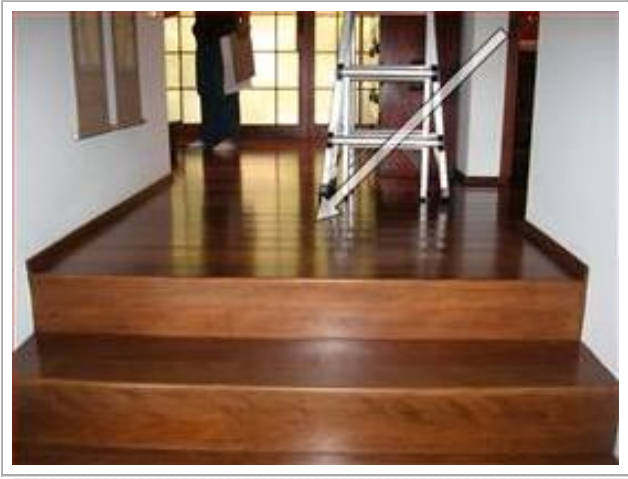
Figure Number 24

Noted minor cupping at wood floor planks at front entry. No active moisture noted. Recommend repairs as needed.
