# ARCHITECH

HOME INSPECTION SYSTEMS, LLC

123 Anykine Dr, Honolulu , Hawaii 96888

**Inspection Date:**  
11/12/2008  
**Prepared For:**  
Ver E. Important  
**Report Number:**  
20081014-BN-1  
**Inspector:**  
Bryan Naff

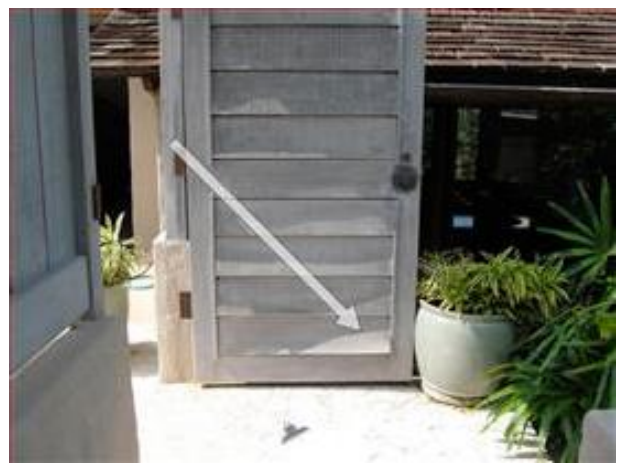
Figure Number 1

Minor repairs may be required at several gates; loose panels, binding latches, weather damage noted. Repair as needed.

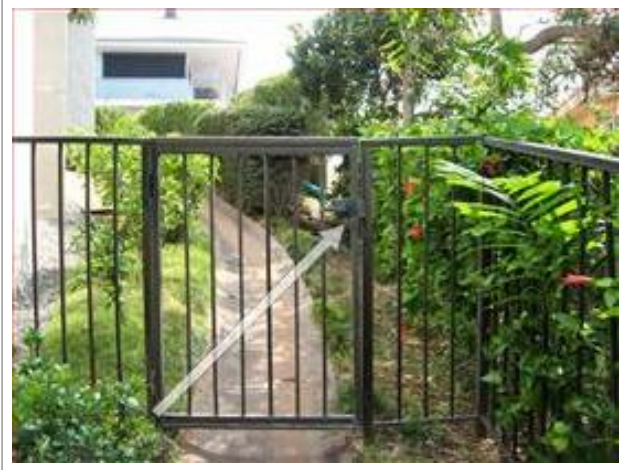
Figure Number 2

Minor repairs may be required at several gates; loose panels, binding latches, weather damage noted. Repair as needed.

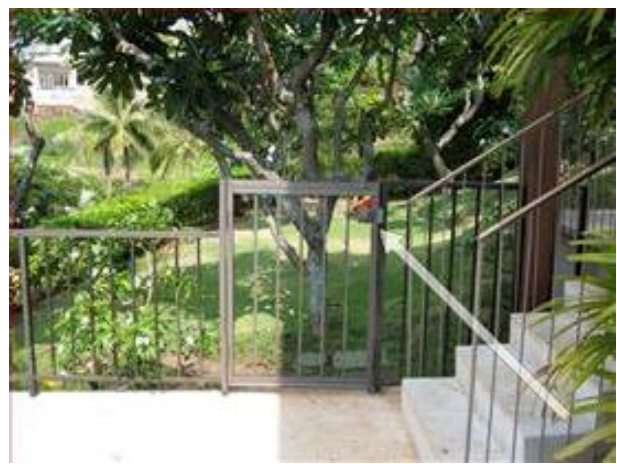
Figure Number 3

Minor repairs may be required at several gates; loose panels, binding latches, weather damage noted. Repair as needed.

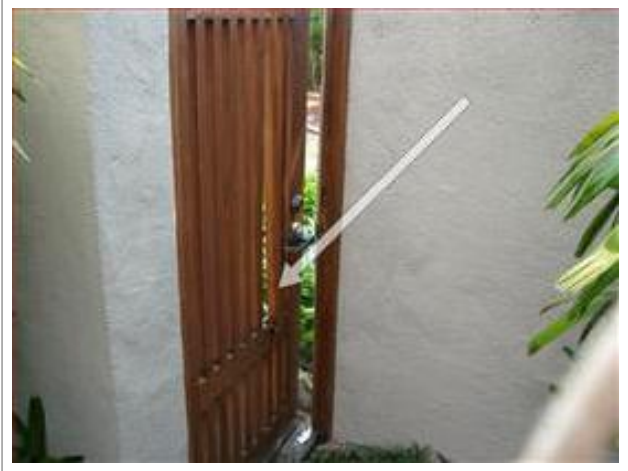
Figure Number 4

Minor repairs may be required at several gates; loose panels, binding latches, weather damage noted. Repair as needed.

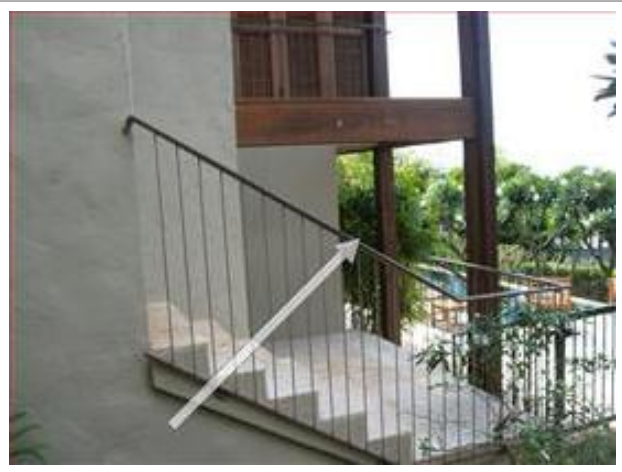
Figure Number 5

Rail caps at right side rear stair are separating from rail. Recommend repairs as needed.

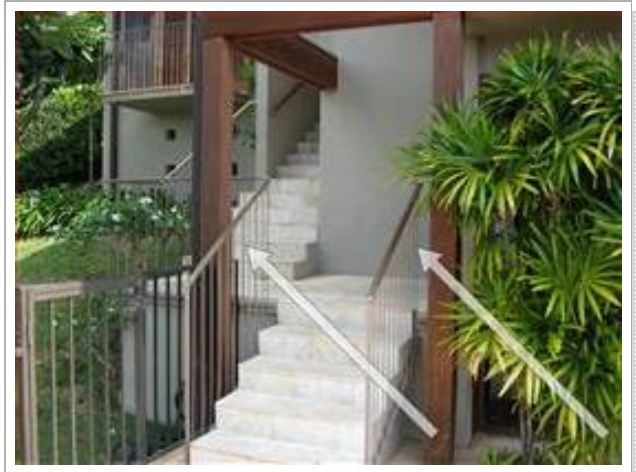
Figure Number 6

Appears the design of the balustrades at the rear right stair creates an inherent instability in the rail. Recommend stabilize as needed.

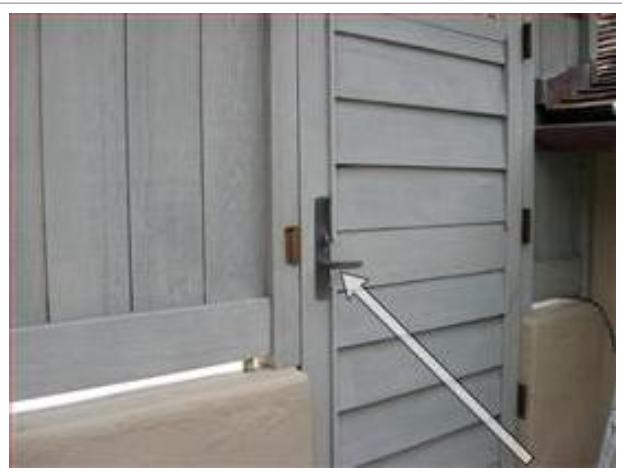
Figure Number 7

Noted lockset at front entry gate in need of minor adjustments/repairs; loose at handle.

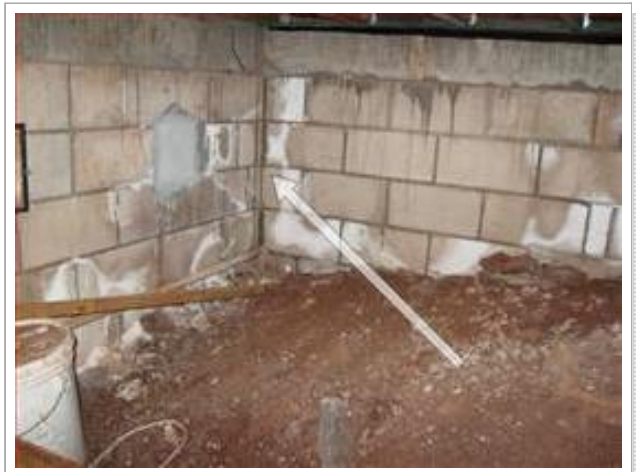
Figure Number 8

Noted efflorescence (white powdery substance) at walls in crawlspace. May indicate migration of moisture through masonry walls. Recommend clean, monitor and repairs as needed.

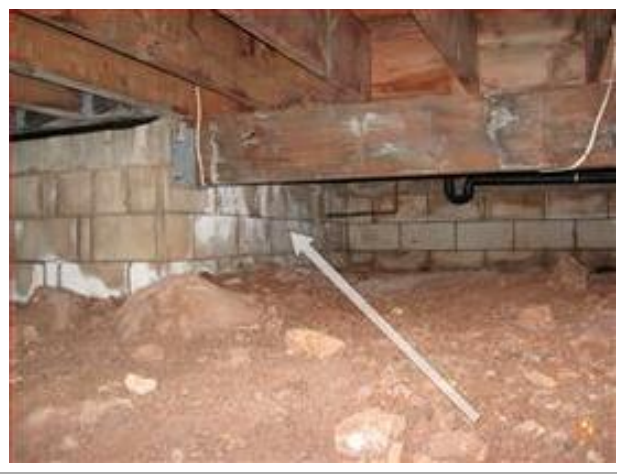
Figure Number 9

Noted efflorescence (white powdery substance) at walls in crawlspace. May indicate migration of moisture through masonry walls. Recommend clean, monitor and repairs as needed.

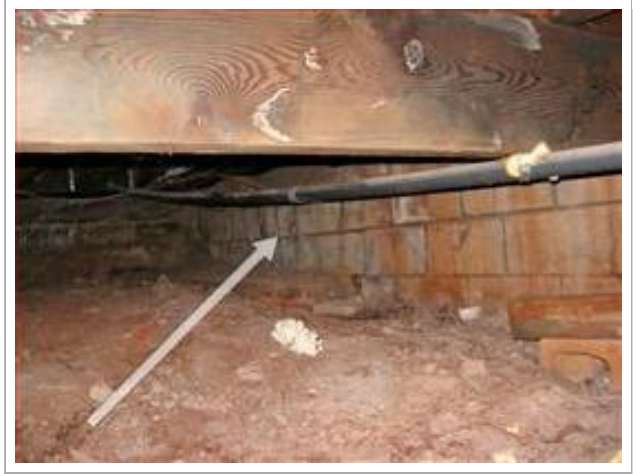
Figure Number 10

Noted efflorescence (white powdery substance) at walls in crawlspace. May indicate migration of moisture through masonry walls. Recommend clean, monitor and repairs as needed.

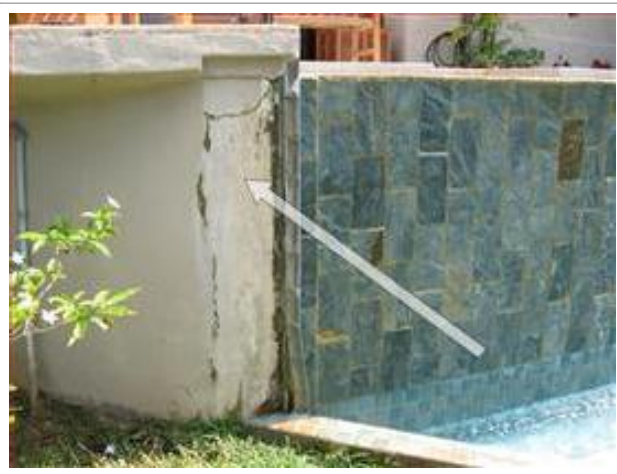
Figure Number 11

Remarks	<ul style="list-style-type: none"> <li>Noted minor cracking and signs of efflorescence at sides of infinity pool walls. Recommend clean and monitor for repair as needed. (See Figure #11) (See Figure #12)</li> <li>See Summary Remarks</li> </ul>

Noted minor cracking and signs of efflorescence at sides of infinity pool walls. Recommend clean and monitor for repair as needed.

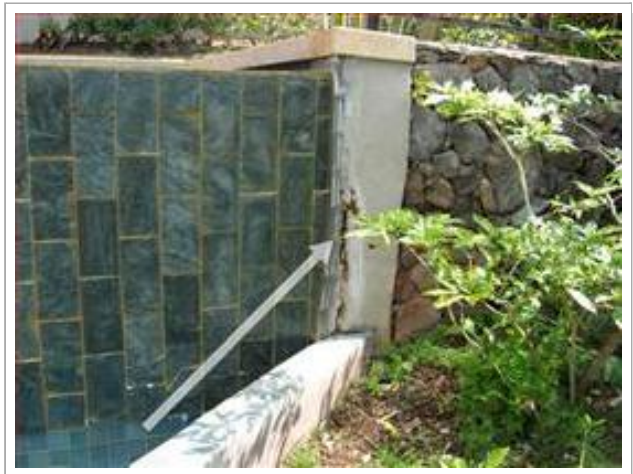
Figure Number 12

Noted minor cracking and signs of efflorescence at sides of infinity pool walls. Recommend clean and monitor for repair as needed.

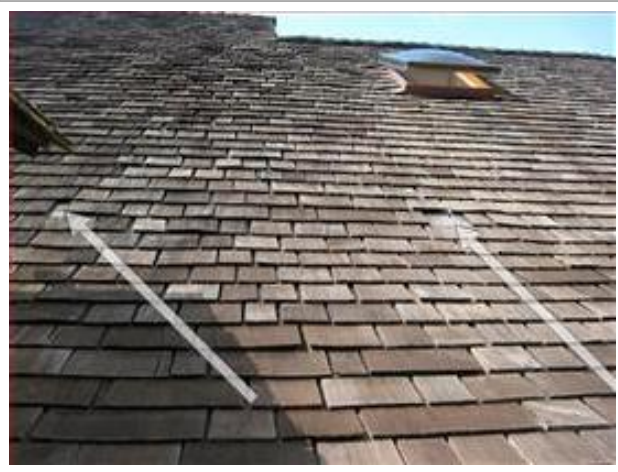
Figure Number 13

Missing shingles noted on various areas of roof. Repair/replace as needed.

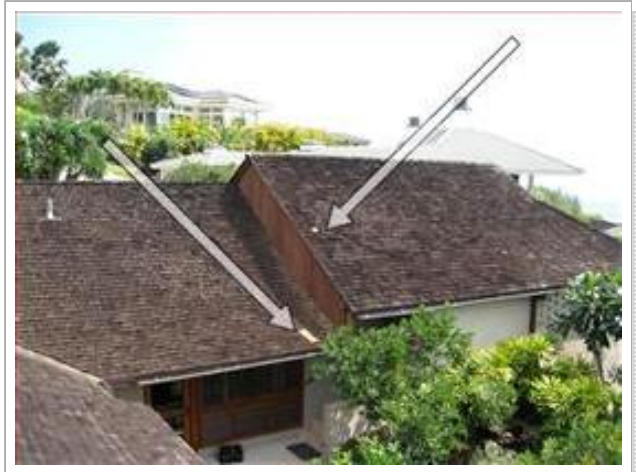
Figure Number 14

Missing shingles noted on various areas of roof. Repair/replace as needed.

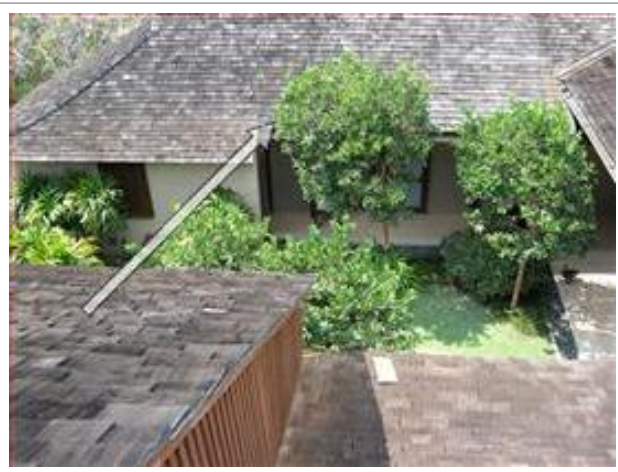
Figure Number 15

Noted tree branches in contact with roof. Recommend trimming tree from roof edge to extend roof life.

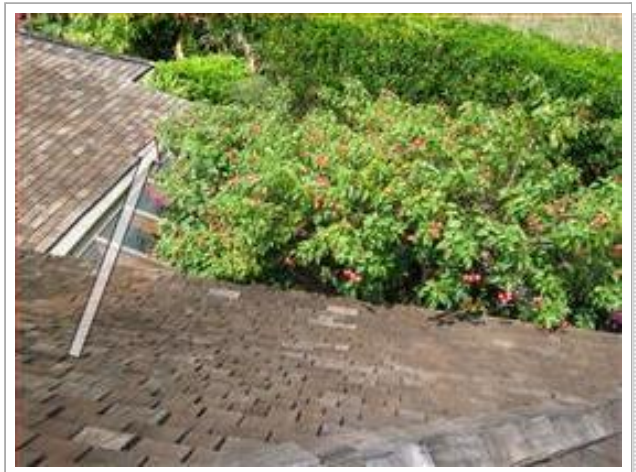
Figure Number 16

Noted tree branches in contact with roof. Recommend trimming tree from roof edge to extend roof life.

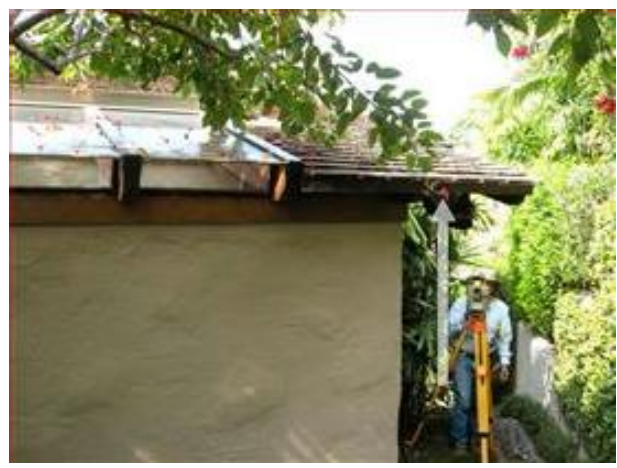
Figure Number 17

Low level moisture stains noted (21%) on wood eaves at right exterior eave. Recommend refinish to extend wood life.

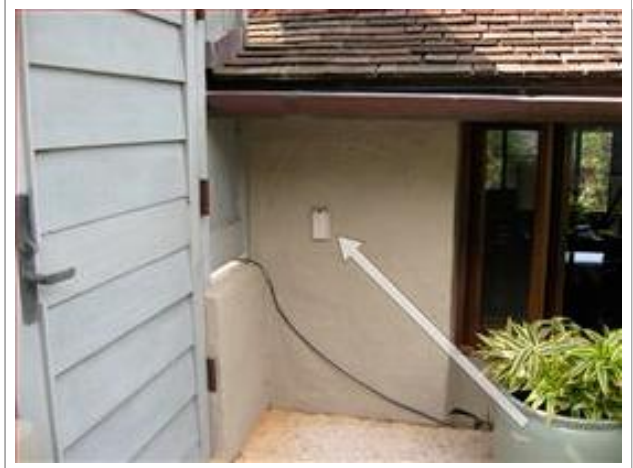
Figure Number 18

Unable to verify operation of switch at front right. Recommend verify with seller.

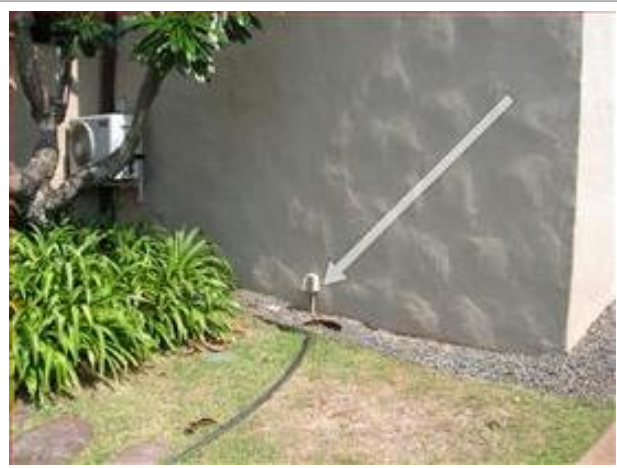
Figure Number 19

Receptacle at middle left exposed conductors and separating from wall. Recommend repairs by qualified electrician as needed.

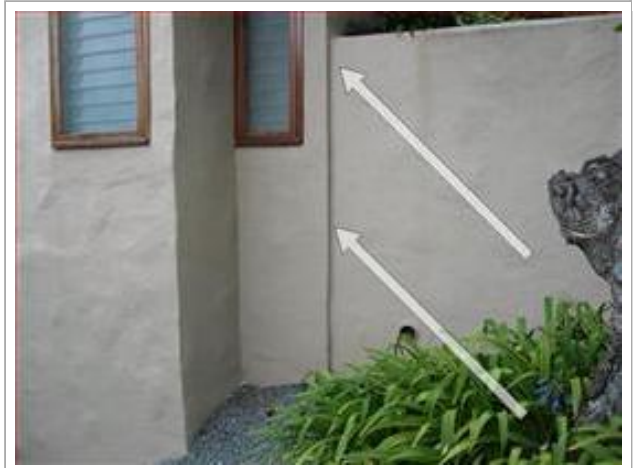
Figure Number 20

Minor separation noted at wall and structure at left middle of exterior. Recommend repairs as needed and monitor.

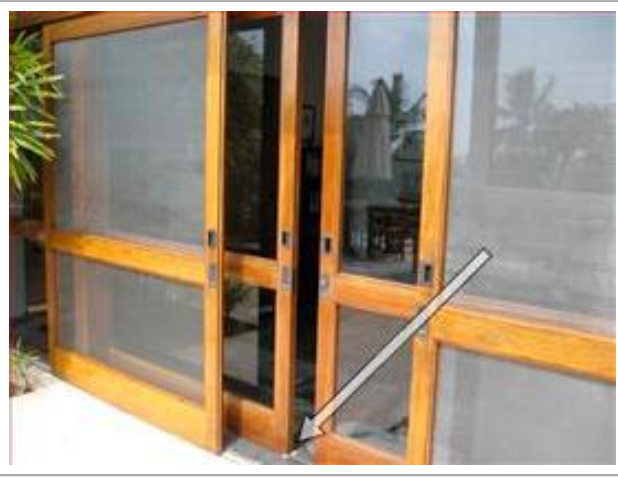
Figure Number 21

Remarks	<ul style="list-style-type: none"> <li>Minor adjustment/repairs may be required at sliding doors at pool. (See Figure #21)</li> <li>See Summary Remarks</li> </ul>

Minor adjustment/repairs may be required at sliding doors at pool.

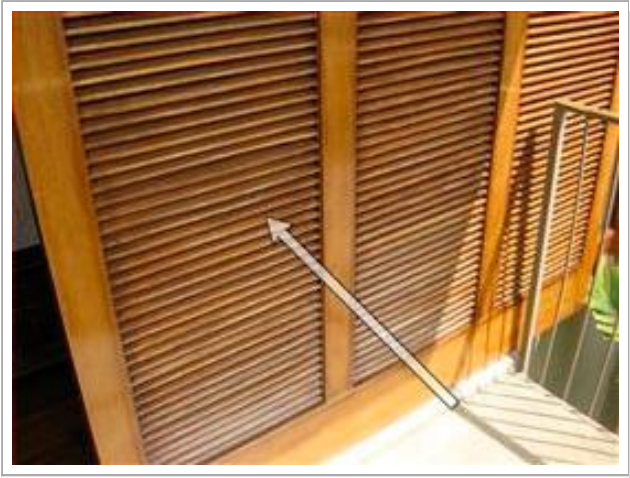
Figure Number 22

Recommend refinish exterior lanai doors of master bedroom to extend life of wood.

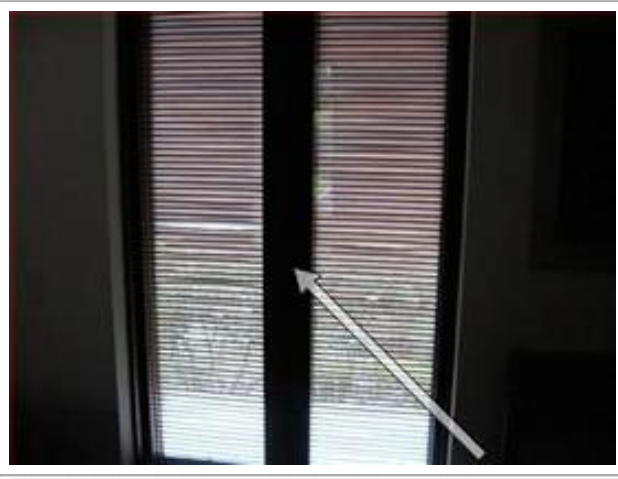
Figure Number 23

Unable to open/operate lockset of lanai doors of 2nd bedroom. Recommend minor adjustments as needed to operate.

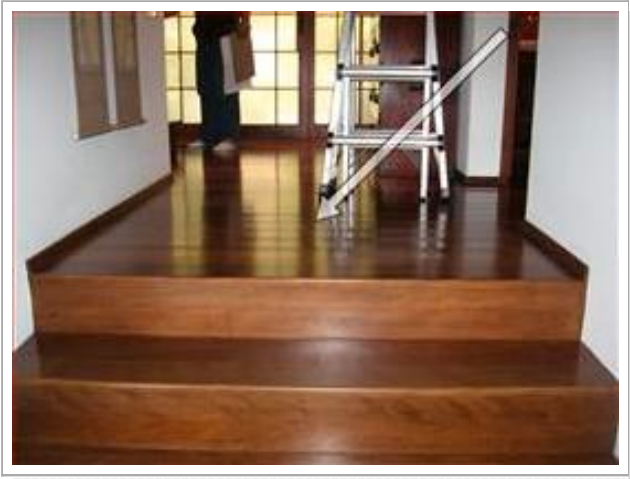
Figure Number 24

Noted minor cupping at wood floor planks at front entry. No active moisture noted. Recommend repairs as needed.

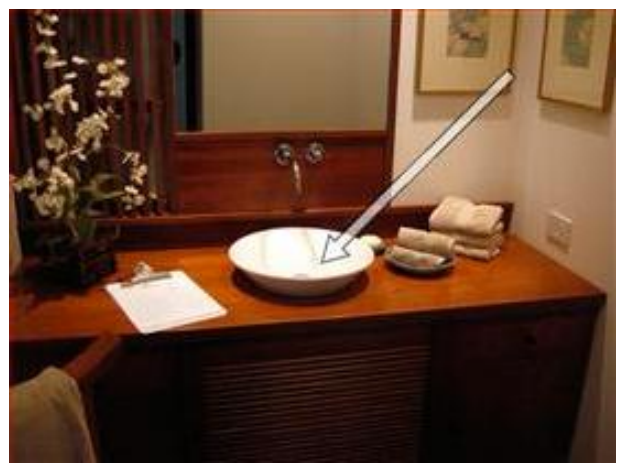
Figure Number 25

Remarks	<ul style="list-style-type: none"> <li>Noted sink in hall bath slow to drain. May indicate minor clog. Repair as needed. (See Figure #25)</li> <li>See Summary Remarks</li> </ul>

Noted sink in hall bath slow to drain. May indicate minor clog. Repair as needed.

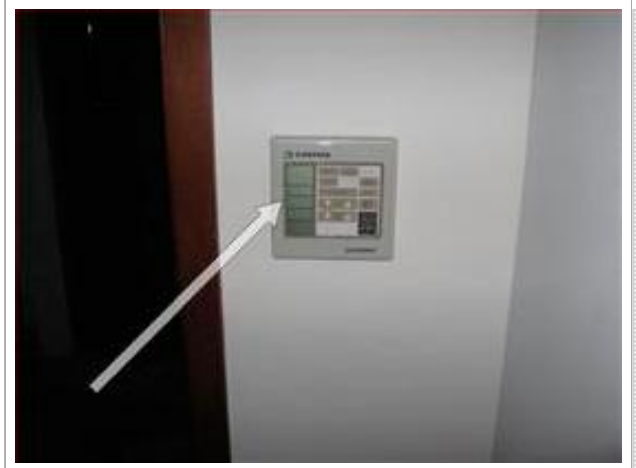
Figure Number 26

A/C control panel in rear right bedroom not operational at time of inspection. Recommend verify operation with seller.

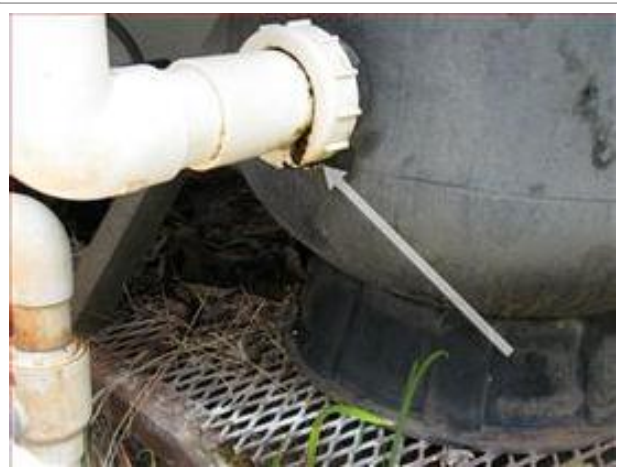
Figure Number 27

Minor water leak/drip noted on connection for pool filter. Repair as needed.

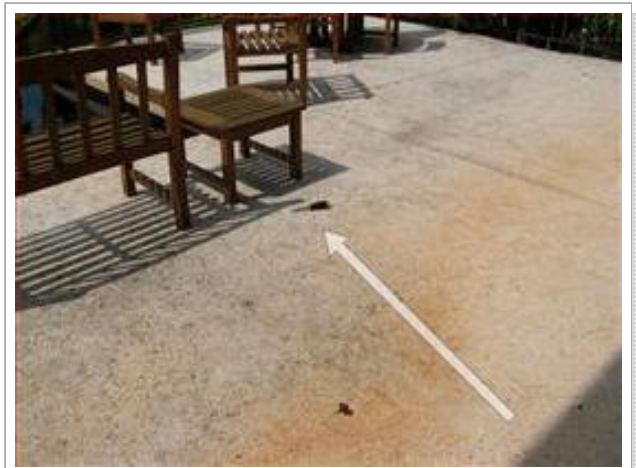
Figure Number 28

Noted hollow sounds at pool deck. Monitor and repair as needed.

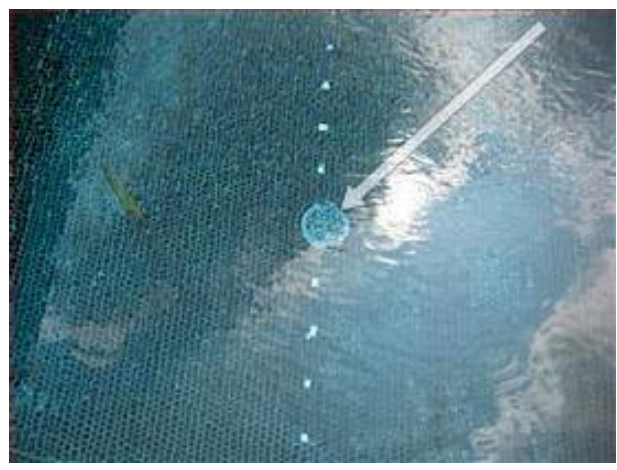
Figure Number 29

Floor return noted at pool. Review possible safety issues regarding this type with pool expert or online.

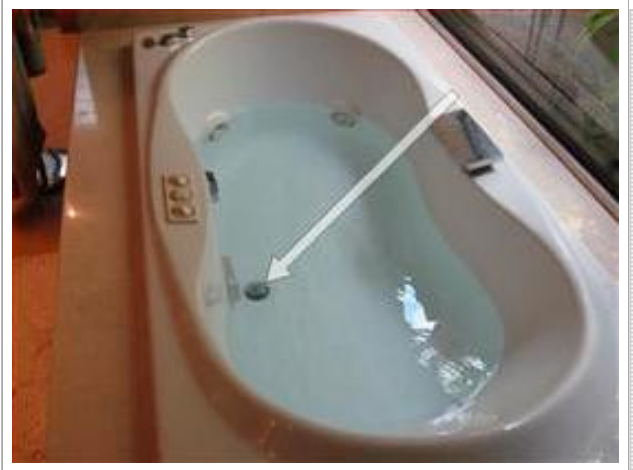
Figure Number 30

Remarks	<ul style="list-style-type: none"> <li>● Tub in master bath was noisy when drained. Repairs recommended as needed. (See Figure #30)</li> <li>● See Summary Remarks</li> </ul>

Tub in master bath was noisy when drained. Repairs recommended as needed.
