Confidential Inspection Report

Prepared For: John & Susan Sample

123 Enikine Street

Honolulu, HI 96815

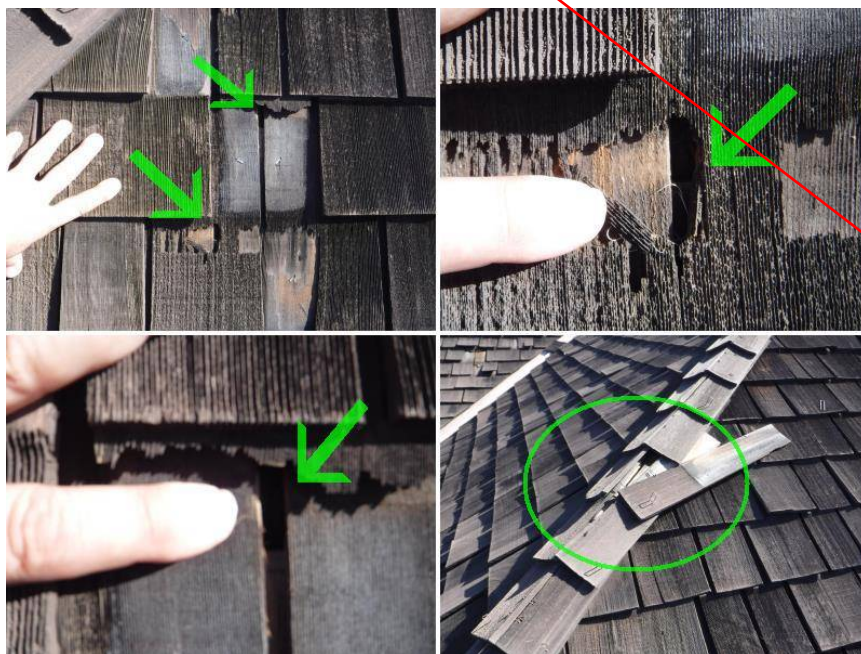
DEFECTIVE - Aging, damaged, and/or cupped shingles were present. We observed exposed matrix/felt which is the waterproofing membrane and is subject to damage from the sun's UV rays. Repairs are needed to ensure adequate weather protection. Any opening in the roof covering is considered an active leak. We recommend further evaluation and repairs as needed by licensed roofing contractor.

IMPLICATIONS Age Related Conditions, May indicate older or worn component, Potential Mechanical Failure and or Moisture Infiltration,

TASK Further Evaluation by an Appropriate Expert or Contractor For Repairs and Costs and or for more information regarding this concern.

TIME Prior to Close off Escrow.

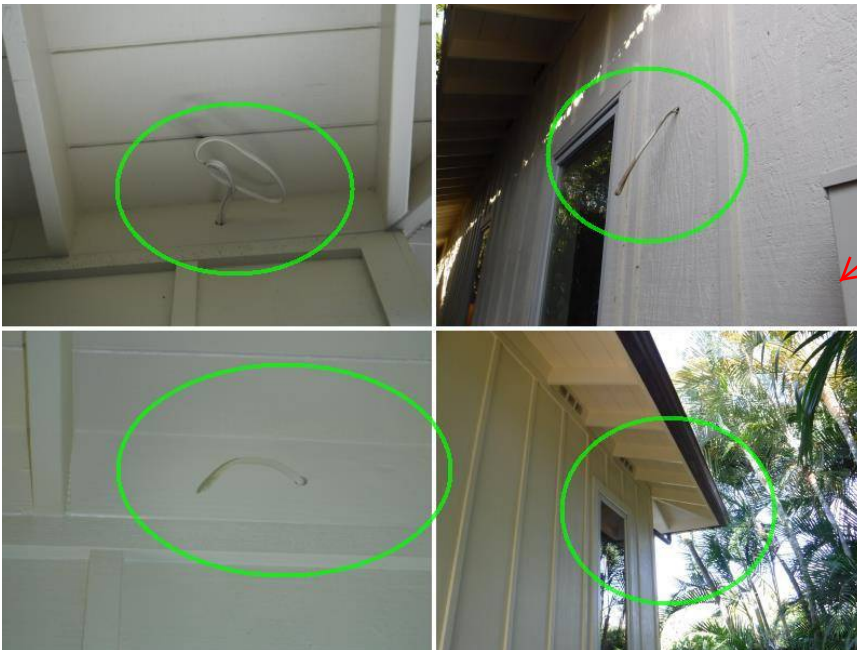
FURTHER EVALUATION Open Live Wiring Observed - Unfinished work and or projects are noted at various areas. You should consult the seller to verify the work will be completed prior to close of escrow or chose to except the conditions as they are,

IMPLICATIONS Incomplete Work, Electrical issues are considered a safety concern until corrected or repaired,

TASK Consult Seller For History of Repair(s), Request documentation,

TIME Prior to Close off Escrow.

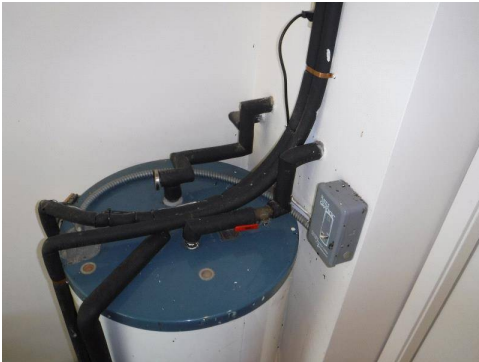
605.7 Solar

DEFECTIVE - Solar System Not Operating - According to the seller the solar water heating system is not operating as intended. There are many possible reasons for this from costly to inexpensive.

Because this system is intended to use solar energy, it is not an efficient "electric" water heater. Updates, repairs and/or replacement are recommended to save money,

TASK Further Evaluation by an Appropriate Expert or Contractor For Cause and Repairs,

TIME As Soon As Possible.

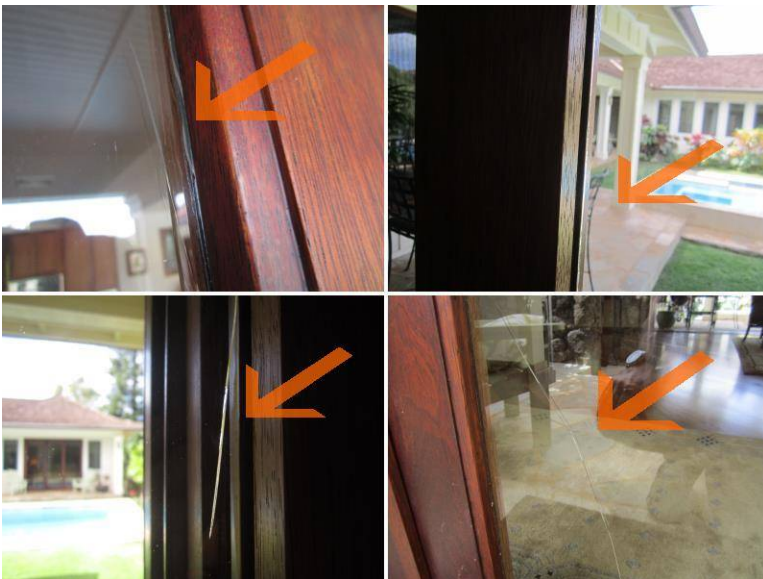
815.1 Outside Door Concerns

REPAIR or REPLACE - Cracks in glass noted on several doors. Due to the number of doors affected, listed as a major concern.

IMPLICATIONS Mechanical Damage,

TASK Further Evaluation by an Appropriate Expert or Contractor For Repairs and Costs,

TIME As Soon As Possible.

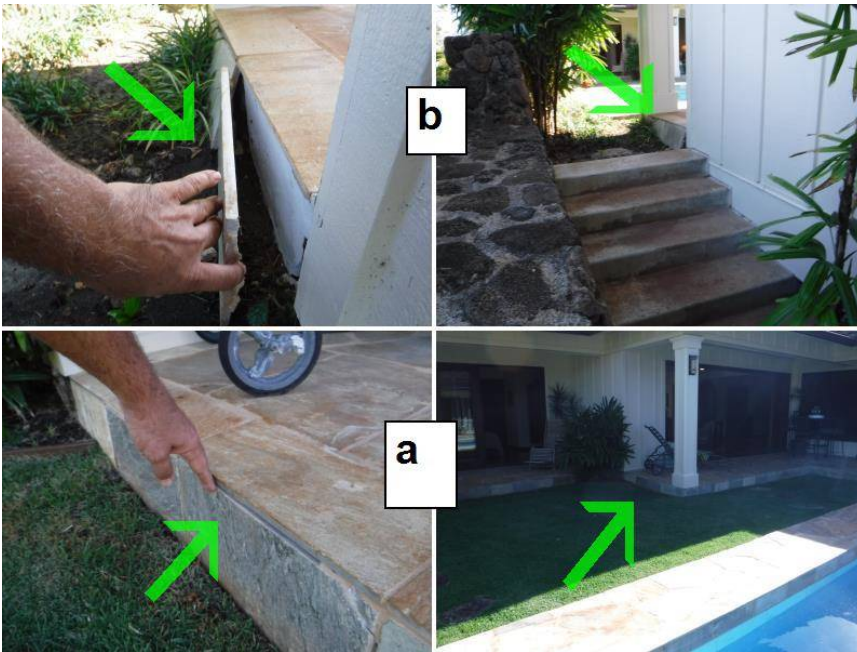
208.1 Lanai Surface

REPAIR or REPLACE

- a] Missing grout @ front right
- b] Loose or poorly secured tiles observed @ rear right,

IMPLICATIONS Mechanical Failure, Potential Mechanical Failure,

TASK Repair or Replace, Components and/or Parts,

TIME Now, & As Required.

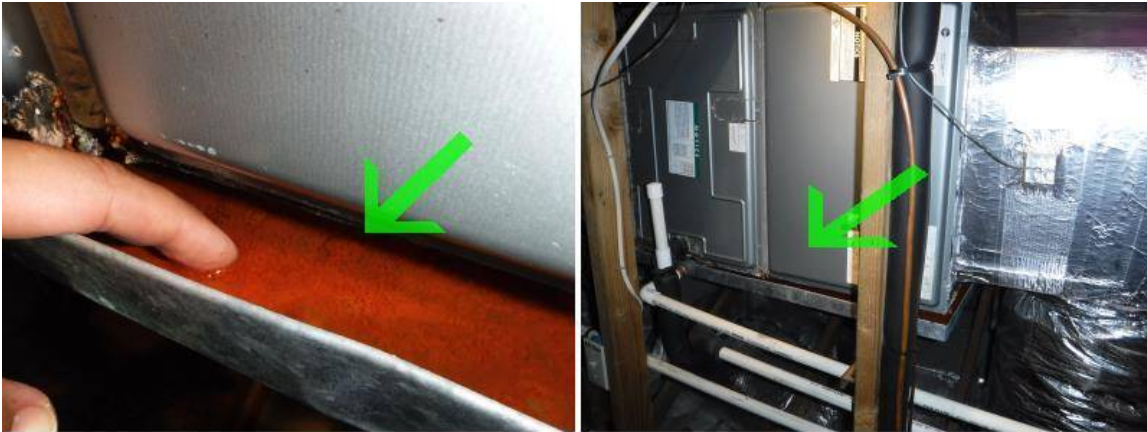
657.1 Condensate Drain Line Concerns

FURTHER EVALUATION - The primary condensate drainpipe may be blocked, We're concerned because rusty water was discovered in the catch pan. The primary condensate drainpipe should be verified as cleared, and the coil should be checked for evidence of a blockage.

- **Additionally**, we observed a condensate line dripping into a P-trap @ rear left, under the house; the trap is overflowing onto the grade. This can be caused by blockage and or simply not enough pressure to push water past the weir line. Further evaluation for cause and repair recommended

TASK Further Evaluation by an Appropriate Expert or Contractor For Cause and Repairs, and/or, for more information regarding this concern,

TIME As Soon As Possible.

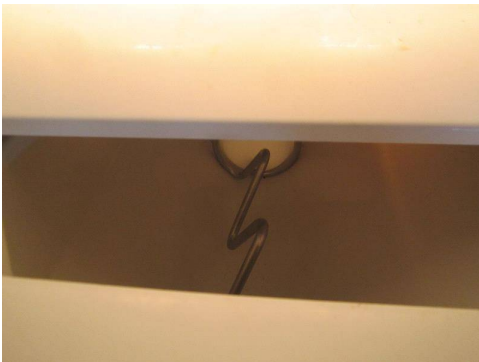
721.1 Refrigerator

REPAIR or REPLACE - Not Making Ice - The ice dispenser is not operational. Water may not be connected but this was not verified

TASK Further Evaluation by an Appropriate Expert or Contractor, For Cause and Repairs,

TIME As Soon As Possible.

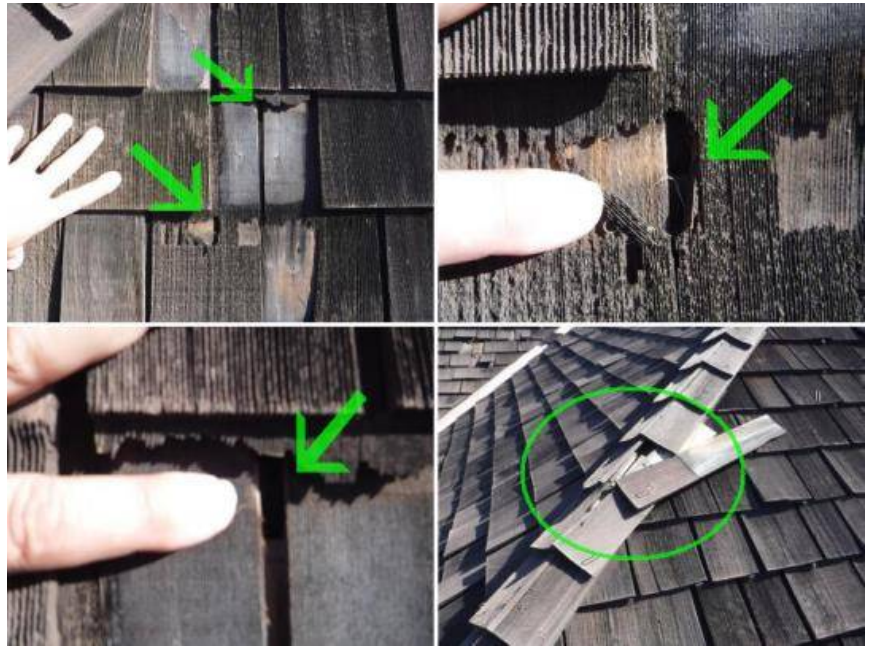
- DEFECTIVE - Aging, damaged, and/or cupped shingles were present.** We observed exposed matrix/felt which is the waterproofing membrane and is subject to damage from the sun's UV rays. Repairs are needed to ensure adequate weather protection. Any opening in the roof covering is considered an active leak. We recommend further evaluation and repairs as needed by licensed roofing contractor.
- LOCATION**, Various Areas Including but not limited to; Rear, Left, Middle,
- IMPLICATIONS** Age Related Conditions, May indicate older or worn component, Potential Mechanical Failure and or Moisture Infiltration,
- TASK** Further Evaluation by an Appropriate Expert or Contractor For Repairs and Costs and or for more information regarding this concern,
- TIME** Prior to Close off Escrow.

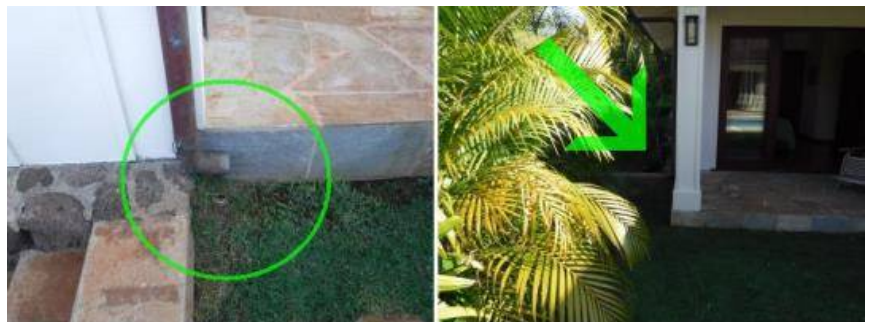
309.1 Downspout Extensions & Runoff Roof Drainage

- UPGRADE or UPDATE** - Installation of downspout extensions would help carry the water further away from the foundation.
- Run-off water needs to flow away from the side of the house at least 6 feet.** This will allow the run-off to get far enough away to not interfere with the foundation.
- LOCATION** Including but not limited to; Right, Side, Middle,
- IMPLICATIONS** Soils near or adjacent to the foundation that are continuously wet can lead to settlement and/or movement issues
- TASK** Install, Further Evaluation by an Appropriate Expert or Contractor
- TIME** As Soon As Possible.

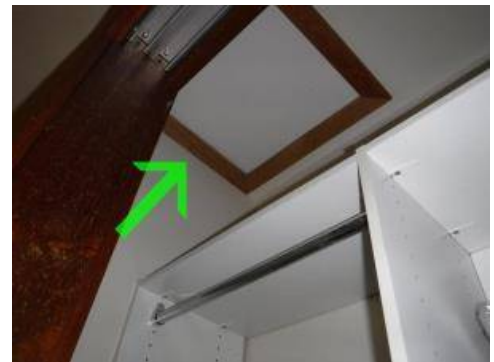
- **FURTHER EVALUATION** Access to the secondary attic or service space in the bedroom closet was not available at this time therefore the attic cannot sensibly be considered "inspected" and we recommend re-inspection when access is made available.
- IMPLICATIONS** Not Readily Accessible; Shelving installed,
- TASK** Further Evaluation by an Appropriate Expert or Contractor when accessible,
- TIME** As Soon As Possible
- NOTE** *Reinspections are not a service that we provide.*

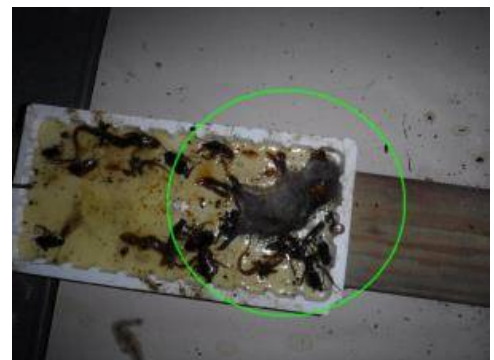
326.5 Attic Pests or Debris

- **MAINTENANCE NEEDED** Rodent in trap(s) noted in attic space.
- LOCATION** Middle along run way,
- IMPLICATIONS**, Chance of Pest Infiltration,
- TASK** Consult Appropriate Expert or Contractor **for Routine treatment**,
- TIME** Now, Ongoing, Discretionary.

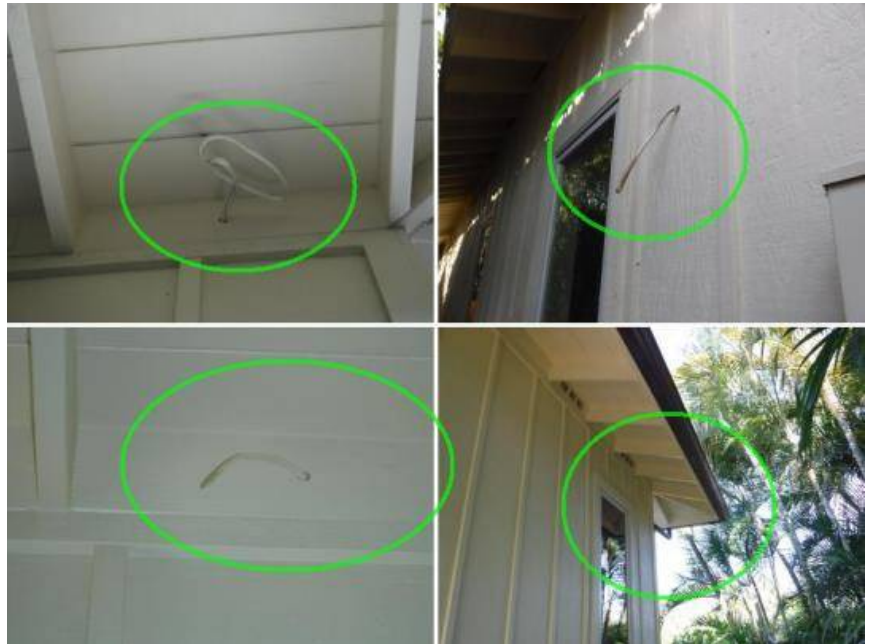
- **FURTHER EVALUATION Open Live Wiring Observed** - Unfinished work and or projects are noted at various areas. You should consult the seller to verify the work will be completed prior to close of escrow or chose to except the conditions as they are, **LOCATION** Various Areas of the House. **IMPLICATIONS** Incomplete Work, Electrical issues are considered a safety concern until corrected or repaired, **TASK** Consult Seller For History of Repair(s), Request documentation, **TIME** Prior to Close off Escrow.

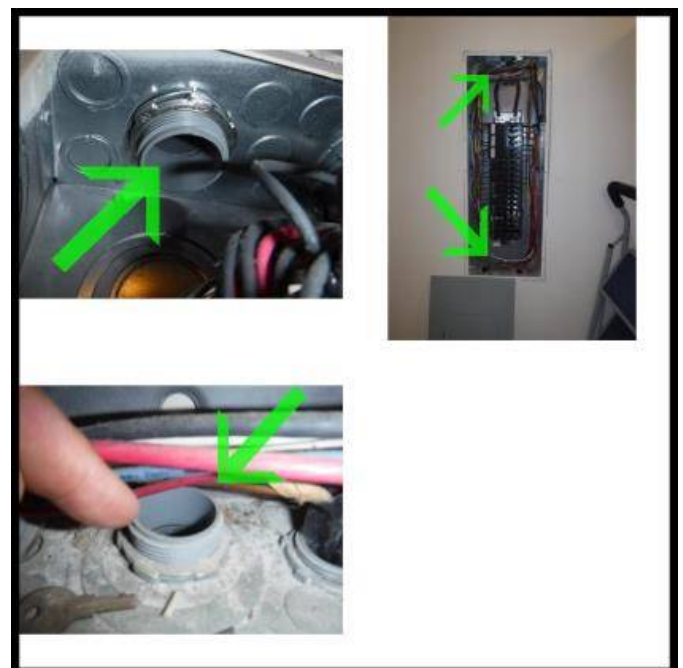
511.1 Cover Panel / Box

- **UPGRADE or UPDATE** There are voids, or open knockouts - Unused openings at the exterior of an electrical panel can allow pest or debris intrusion. Small metal covers made for covering such openings are available at most hardware stores for under \$3 and should be installed,
- LOCATION** Top, and Bottom
- IMPLICATIONS** Practices that are widely or generally considered problematic, Chance of Pest Infiltration
- TASK** Correct,
- TIME** As Soon As Possible, At next professional servicing

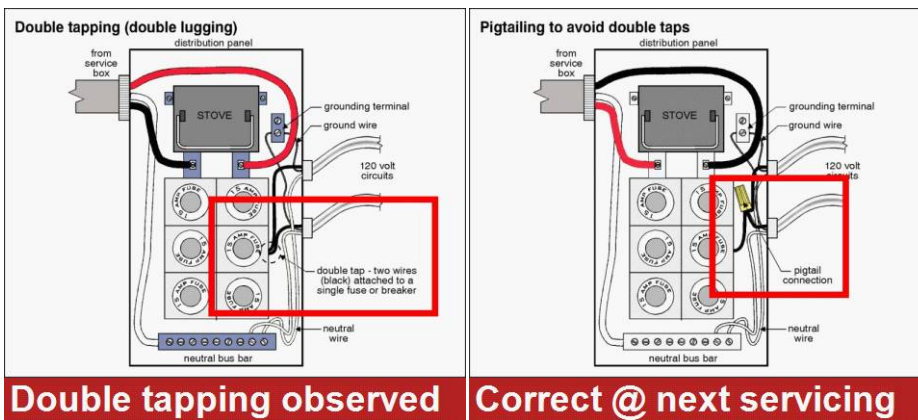
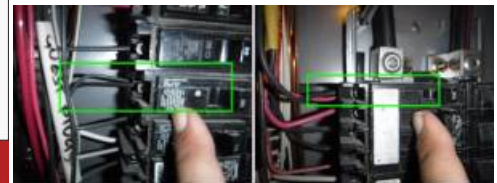
Double tapping observed

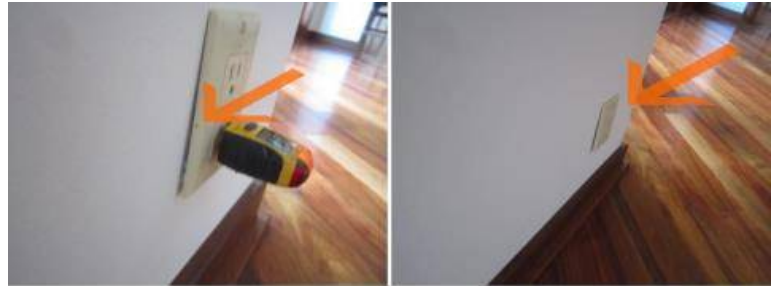
- **SAFETY CONCERN** - Electrical receptacle is loose at the wall,
- LOCATION** Kitchen area,
- IMPLICATIONS** Electrical issues are considered a safety concern until corrected or repaired,
- TASK** Repair or Replace,
- TIME** As Soon As Possible.

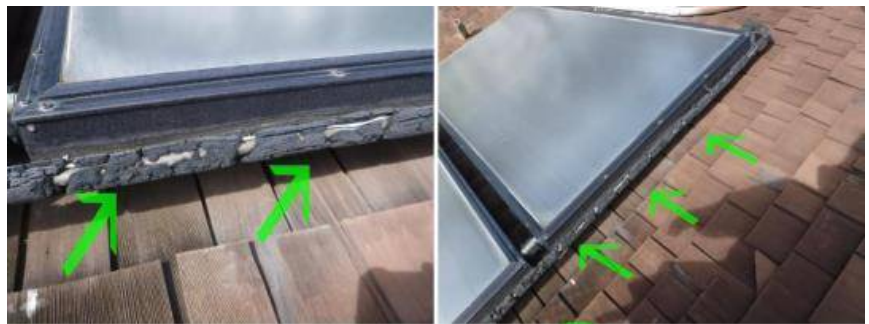
- **REPAIR or REPLACE** - The insulation at the solar supply and return pipes at the roof are deteriorated to the point that replacement is recommended,
IMPLICATIONS, Age Related Conditions, At, or beyond statistical life span or usefulness,
TASK Replace, Components and/or Parts,
TIME As Soon As Possible.

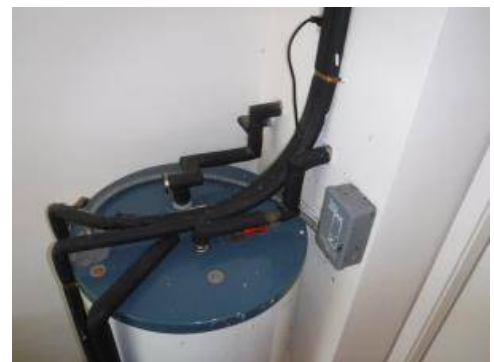
605.7 Solar

- **DEFECTIVE - Solar System Not Operating** - According to the seller the solar water heating system is not operating as intended. There are many possible reasons for this from costly to inexpensive.
Because this system is intended to use solar energy, it is not an efficient "electric" water heater. Updates, repairs and/or replacement are recommended to save money,
LOCATION Garage,
IMPLICATIONS, Not Operational, Wasted Resources,
TASK Further Evaluation by an Appropriate Expert or Contractor For Cause and Repairs,
TIME As Soon As Possible.

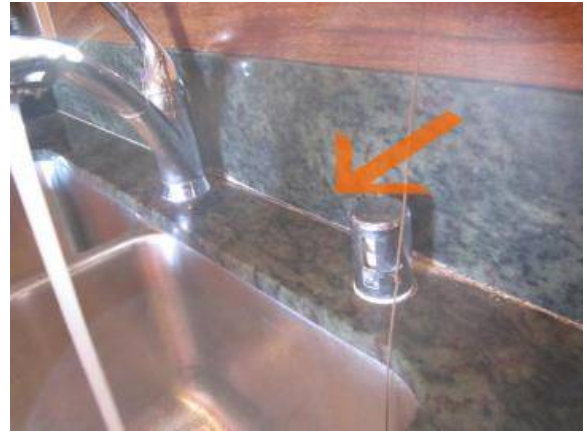
706.1 Counter Concerns

- **UPGRADE or UPDATE** The countertops in the kitchen need attention - Updating of caulking behind sink is recommended to prevent possible water damage to cabinet below,
IMPLICATIONS Material Deterioration,
TASK Update,
TIME As Required.

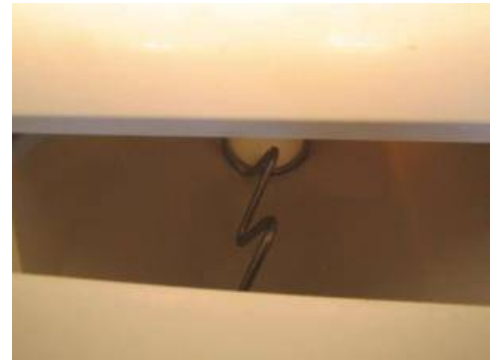
721.1 Refrigerator

- **REPAIR or REPLACE - Not Making Ice** - The ice dispenser is not operational. Water may not be connected but this was not verified
IMPLICATIONS Not Operating as Intended
TASK Further Evaluation by an Appropriate Expert or Contractor, For Cause and Repairs,
TIME As Soon As Possible.

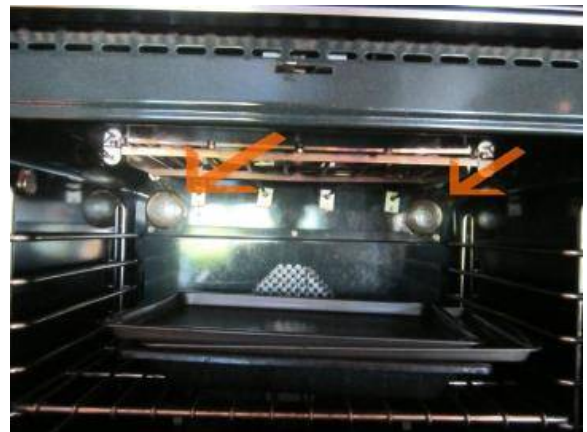
722.1 Range

- **REPAIR or REPLACE** Light bulbs in oven need possible replacement,
IMPLICATIONS Not Operating as Intended
TASK Repair or Replace,
TIME As Required.

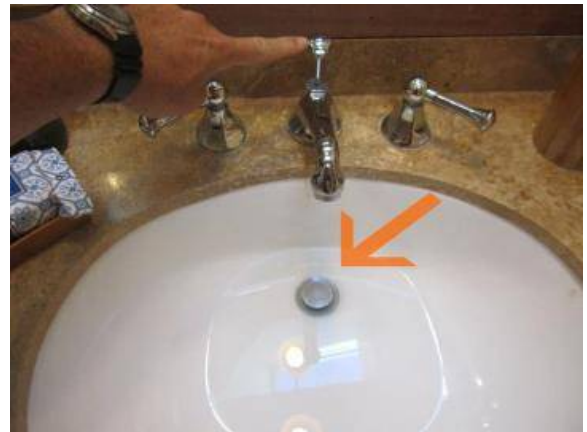
- **REPAIR or REPLACE** - The basin stopper did not hold water. Some adjustment and/or repair may be needed
- LOCATION** Right side sink
- IMPLICATIONS** Not Operating as Intended
- TASK** Repair or Replace, Components and/or Parts,
- TIME** As Required.

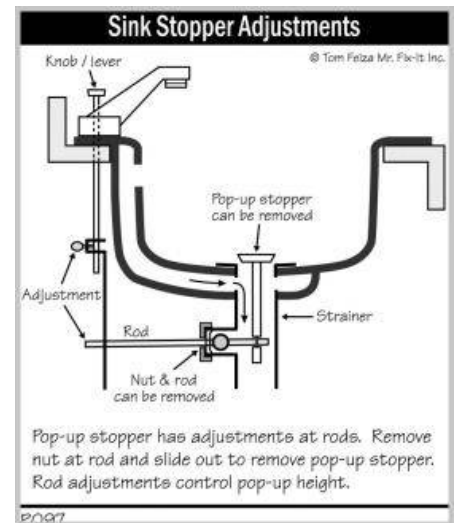
Jack And Jill Bathroom

- **REPAIR or REPLACE** - The basin stopper is missing and/or damaged. Recommend repair/replace as needed.
- LOCATION** Both sinks
- IMPLICATIONS** Not Operating as Intended
- TASK** Repair or Replace, Components and/or Parts,
- TIME** As Required.

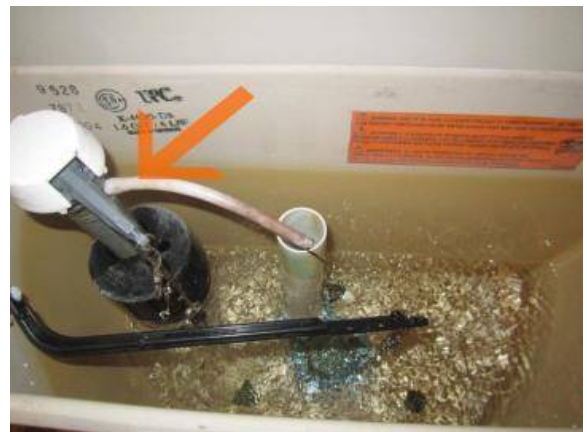
770.1 Toilet/Lavatory Concerns

- **UPGRADE or UPDATE Leak at flush valve** Inexpensive Update
- Recommendations** - Flush Valve - When replacing the flush valve, be sure to replace it with an approved anti-siphon & backflow rated fill valve. Anti-siphon and backflow rated valves are installed to prevent toilet tank water from re-entering the potable water supply. This type of valve is required in most jurisdictions. However, usually both the non-rated and the new are available.
- IMPLICATIONS** Age Related Conditions, May indicate older or worn component,
- TASK** Repair or Replace, Older or Worn Components or Parts,
- TIME** As Soon As Possible.

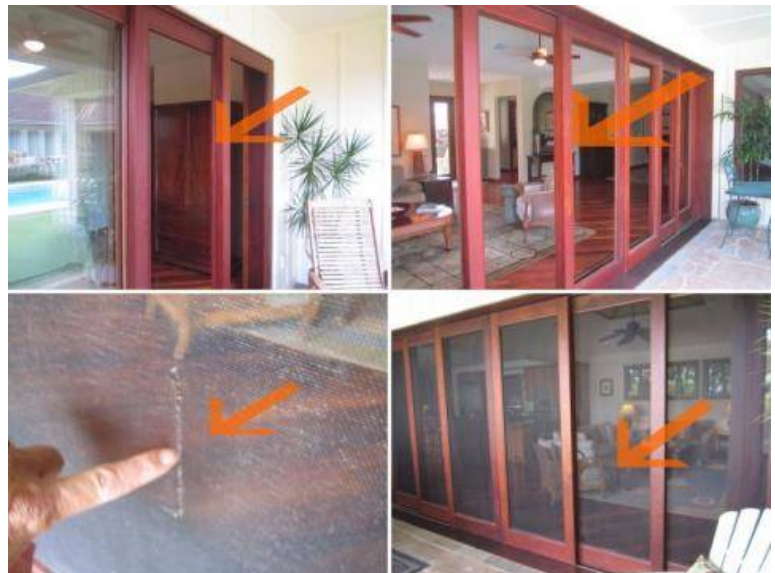
- **REPAIR or REPLACE** - Torn door screen observed, screens removed,
- LOCATION** Sliding doors in living room, guest bedroom,
- IMPLICATIONS** Chance of Pest Infiltration,
- TASK** Repair or Replace,
- TIME** As Soon As Possible.

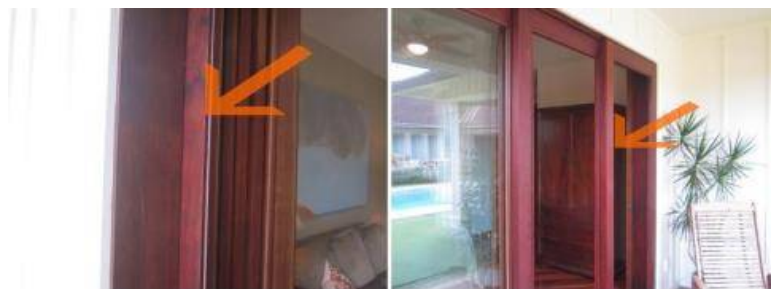
815.3 Outside Door Concerns

- **MAINTENANCE NEEDED** - Sliding screen door glides, wheels or rollers need adjustments to operate properly.
- LOCATION** Living room, guest bedroom,
- IMPLICATIONS** Not Operating as Intended
- TASK** Repair or Replace,
- TIME** As Required.

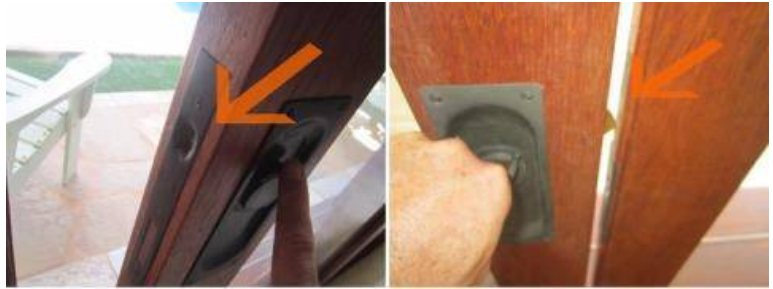
- SAFETY CONCERN** - At least one outside entry door needs some adjustment, repair or replacement; Lock set appears misaligned, not latching,
- LOCATION** Master bedroom, living room,
- IMPLICATIONS** Not Operating as Intended
- TASK** Repair or Replace,
- TIME** As Soon As Possible.

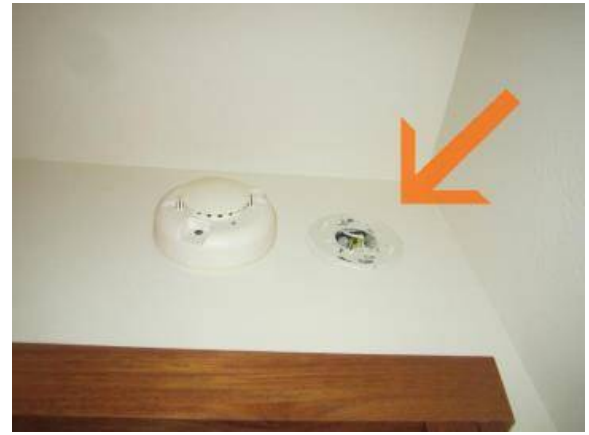
802.1 Hallway Concerns

- REPAIR or REPLACE** - Missing smoke alarm,
- LOCATION** Hallway near office,
- IMPLICATIONS** Safety Concern,
- TASK** Install,
- TIME** As Soon As Possible.

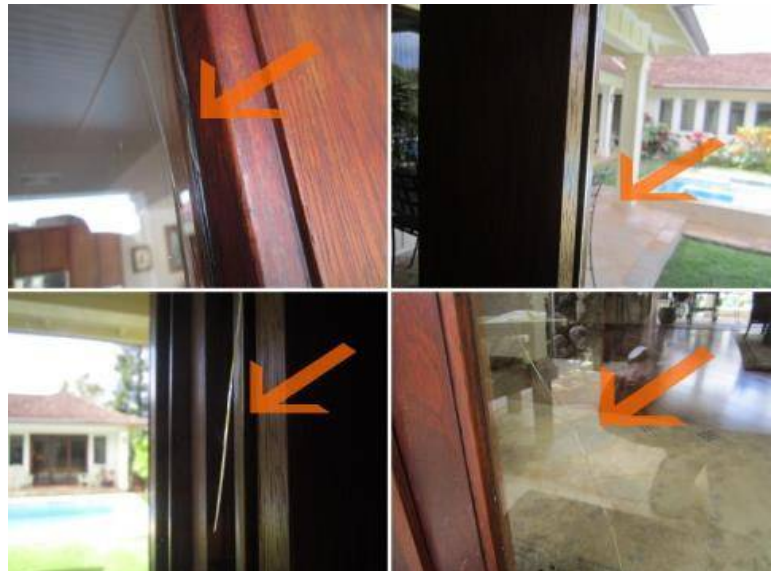
815.1 Outside Door Concerns

- REPAIR or REPLACE** - Cracks in glass noted on several doors. Due to the number of doors affected, listed as a major concern.
- LOCATION** Various sliding doors, front entry door,
- IMPLICATIONS** Mechanical Damage,
- TASK** Further Evaluation by an Appropriate Expert or Contractor For Repairs and Costs,
- TIME** As Soon As Possible.
