Confidential Inspection Report

Prepared For: John & Susan Sample
123 Enikine St, Apt 502
Honolulu, HI 12345
[09/10/2020]

Prepared by: Architech Inspection Systems • 808-372-2535 • ahi@ahipro.com

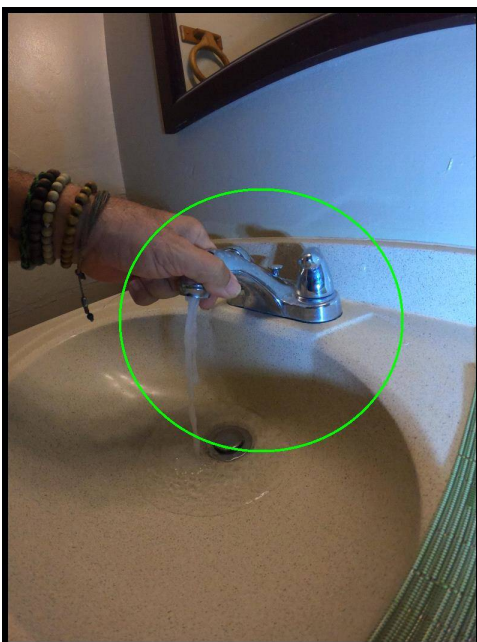
752.1 Sink Hardware Concerns

REPAIR or REPLACE - the sink faucet and/or spigot in this bathroom is loose at the base and should be secured,

IMPLICATIONS Mechanical Failure,

TASK Repair or Replace

TIME As Soon As Possible

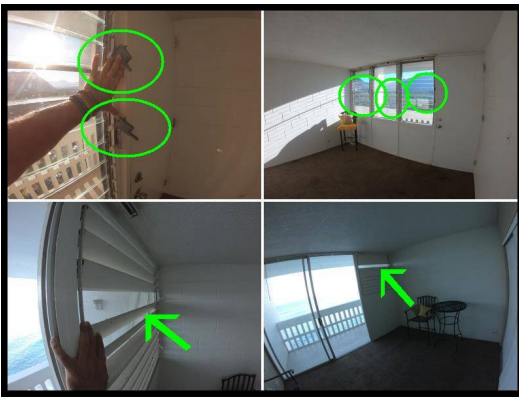
REPAIR or REPLACE Jalousie window hardware needs repair or replacement; Components appear older damaged and or unreliable. Missing slat in bedroom. Missing and damaged cranks

IMPLICATIONS Age Related Conditions; Indicates older or worn component, Difficult to operate or not operational

TASK Repair or Replace Older or Worn Components or Parts

TIME As Soon As Possible

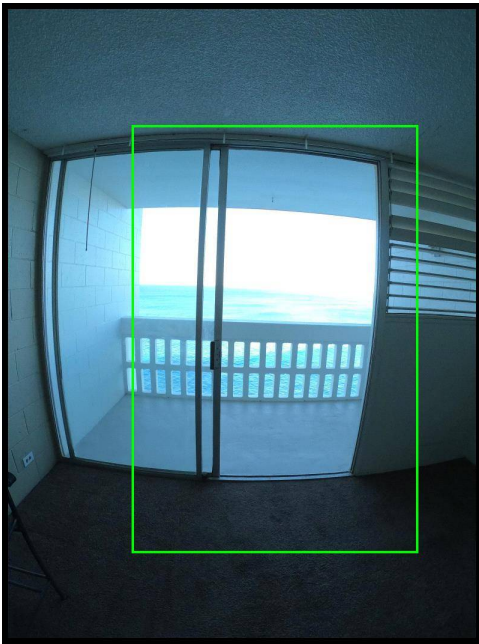
805.1 Screen Door Concerns

ADVISORY No screens installed - Screens missing or removed from at least one window in this room, recommend replace.

IMPLICATIONS Missing or Removed Parts or Components

TASK Budget for Replacement

TIME As Required

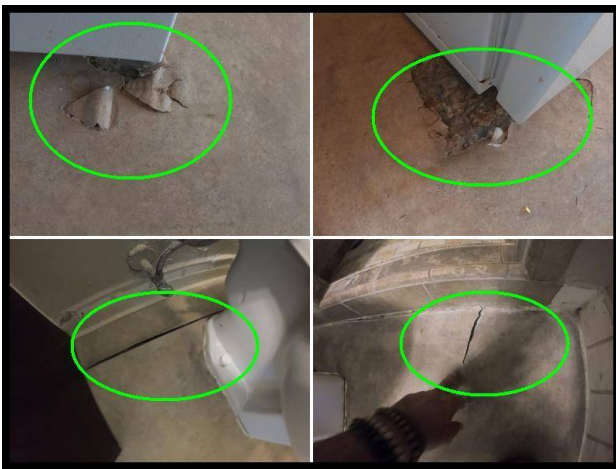
811.20 Vinyl Floor Concerns

MARGINAL Damage to floors may include due to heavy objects being dragged across floors, impact damage, lifting or burns. We aren't worried about cosmetics but are interested in performance issues

IMPLICATIONS Cosmetic Defects, Damaged Components

TASK Further Evaluation by an Appropriate Expert or Contractor For Repairs/Updates and Costs

TIME As Soon As Possible

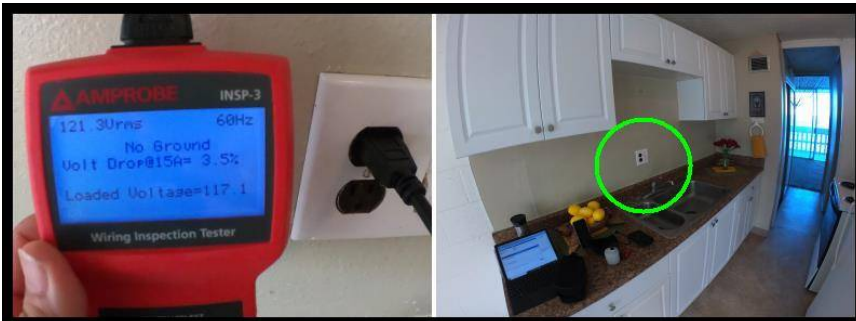
262.10 Electrical Receptacles

REPAIR or REPLACE Open Ground | An electrical receptacle had an open ground. No GFCI protection. Poor Location

IMPLICATIONS Improper Wiring, Electrical issues are considered a safety concern until corrected or repaired

TASK This condition is a defect which should be corrected by a qualified electrical contractor.

TASK Further Evaluation by an Appropriate Expert or Contractor For Cause and Repairs

TIME As Soon As Possible

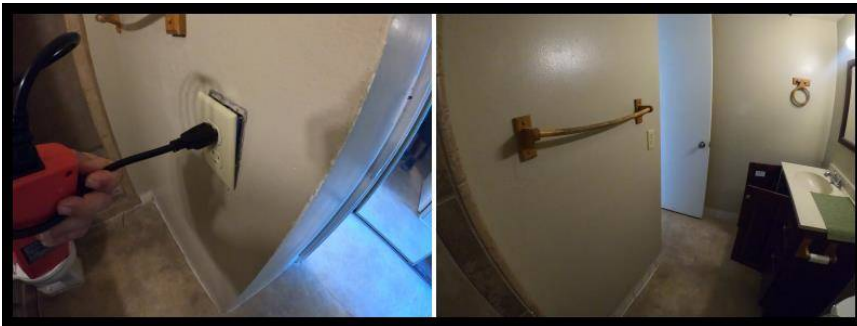
REPAIR or REPLACE Receptacle is loose and/or gapping at the wall. Loose receptacle may become a safety concern.

Additionally - No GFCI protection and too far from vanity or station; Extension cords are safety hazard

IMPLICATIONS Loose or moving parts or components, Potential Safety Concern

TIME As Soon As Possible

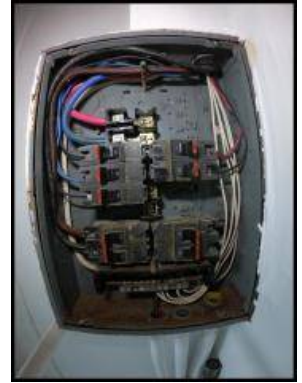
Informational: If a breaker is reset and trips back off, this is an indication that there is a short or weakened condition in the circuit. Call a qualified licensed electrician for analysis of the existing problem.

Serviceable - The breakers in this power panel appear to be appropriately matched to the circuit wire gauge.

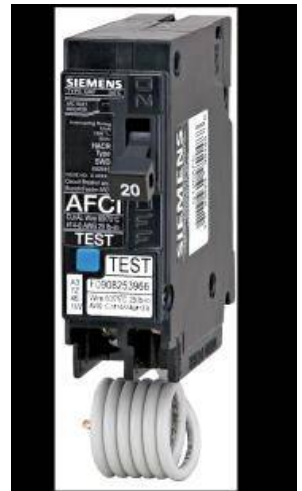
None Noted ~ missing in recommended areas; Updates and/or further evaluation recommended

None, Predates Requirement | This structure predates the requirement for newer construction of Arc Fault protected outlets.

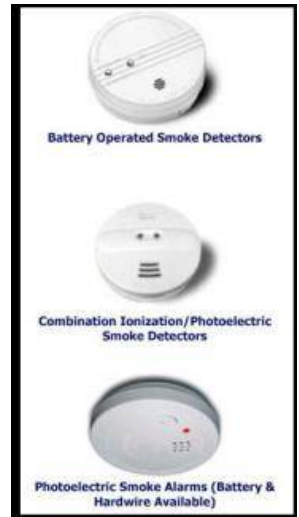
- **Smoke/Fire Detection Devices** **The existing smoke/fire detectors were not tested**, but they are noted as to presence. We do not test the smoke detectors because they may work today but not work when you need them to work. This is why it is important for **you** to test them on a regular basis, monthly at least. *Smoke detectors require replacement after 10 years, so if the residence is older or you are not sure of the age, you should consider updating the current smoke detectors with new ones. Installation Recommendations | Smoke detectors are recommended by the U.S. Product Safety Commission to be installed inside each bedroom and/or sleeping area and adjoining hallway and on each living level of the home [and basement level]*

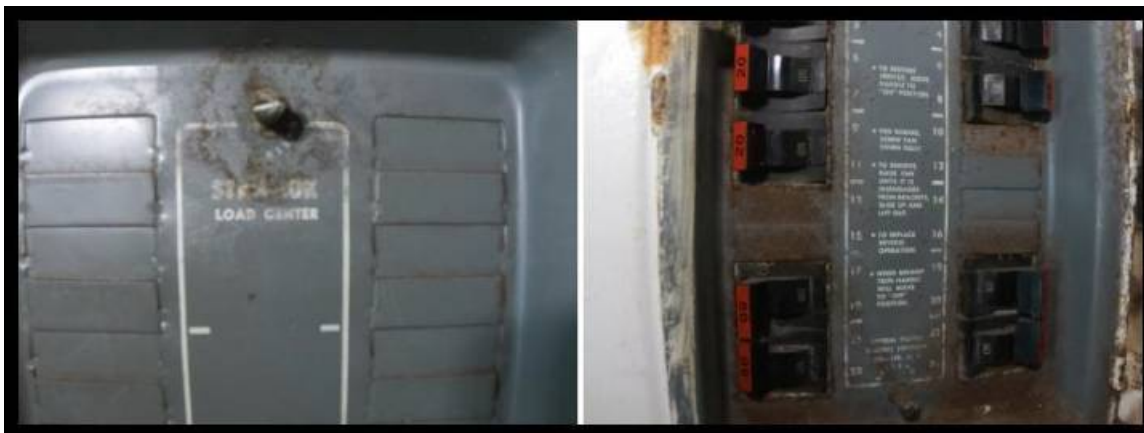
- **ADVISORY Known History of Issues/Concerns - Federal Pacific Electric Stab Lok Panel** - The panel was manufactured by Federal Pacific, and is alleged to be defective. And although I may have found no current deficiencies with this panel, the original manufacturer is now out of business and components are hard to obtain, but there have been enough issues and related problems for me to recommend that you consult with an electrician to discuss some of these issues and options for upgrades as needed. However, you can learn more about this for yourself at <http://inspectapedia.com/fpe/fpepanel.htm>
IMPLICATIONS Known History of Issues, No Immediate Concerns Observed at This Time
TASK Consult Appropriate Expert or Contractor for more information regarding this concern
TIME As Required, Discretionary

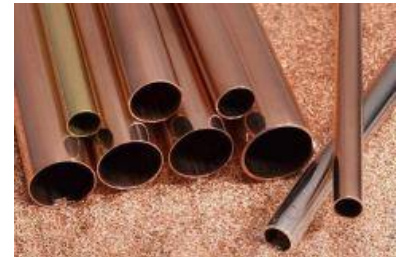
Not Visible - Unable to determine - Presumably Copper | but we were unable to verify this visually to confirm. The life expectancy of copper plumbing is 60-90 years, though intermediate repairs may be necessary much sooner

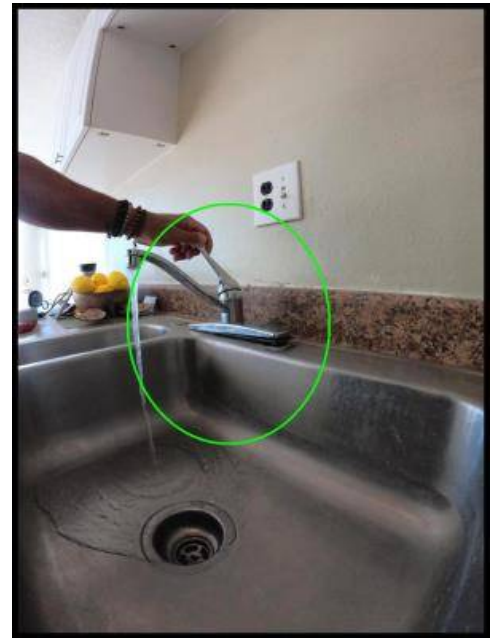
- UPGRADE or UPDATE** Faucet appears serviceable but loose at base. Repairs or updates are recommended as needed.
IMPLICATIONS Potential for Mechanical Failure, Does not appear to effect current operation
TASK Would benefit from updates and/or upgrades
TIME As Soon As Possible

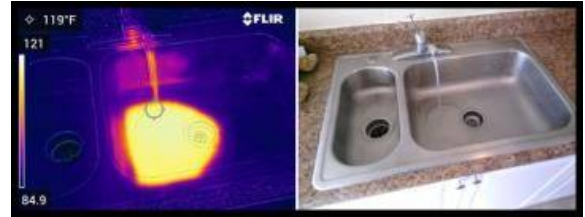
- Capacity
- Water Temperature

A 30 gallon water heater is installed.
 116 - 120 degrees fahrenheit @ interior spigot/faucet
OK The ideal water temperature as it exits the spigots should be set at a minimum of 106f degrees (which most people find "hot") and a maximum of 120f degrees to prevent scalding

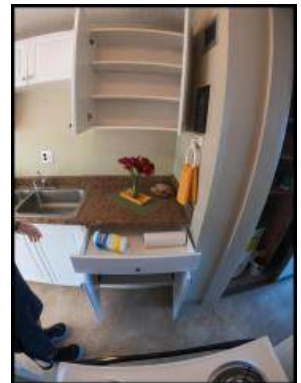
Serviceable

Predictable wear and tear noted, Mainly cosmetic

Counter Type - Laminate

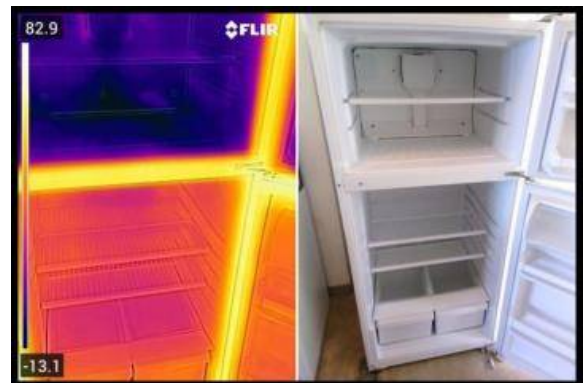
There is currently no visible water source for the refrigerator

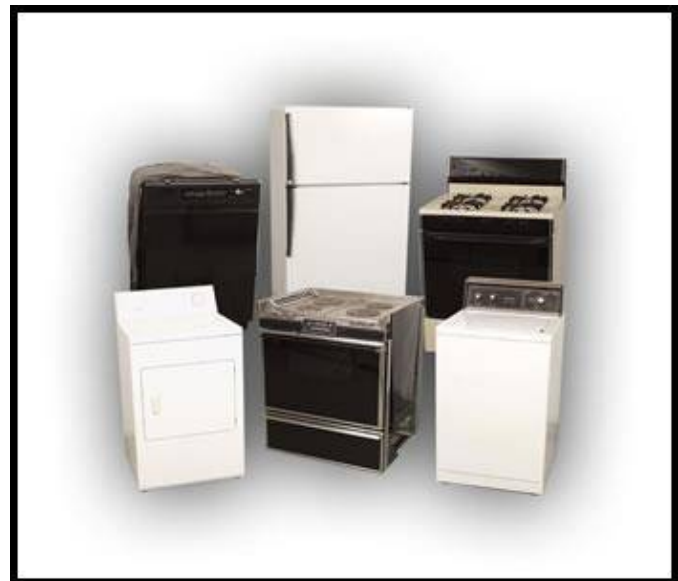
715.1 Older Kitchen Appliances

- **ADVISORY** - Older appliances observed, The components here show signs of age and predictable wear and tear. *Upgrades and or repairs should be expected.*
- IMPLICATIONS** Nearing or at End of Useful or Statistical Life
- TASK** Budget for replacement,
- TIME** Now, As Required or Discretionary.

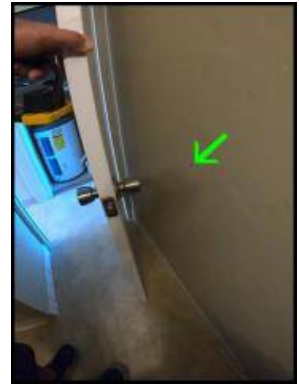
Door(s): Serviceable ~ *Missing door bumpers may cause or be causing damage to adjacent walls and/or doors. **Damage at wall***
No Windows

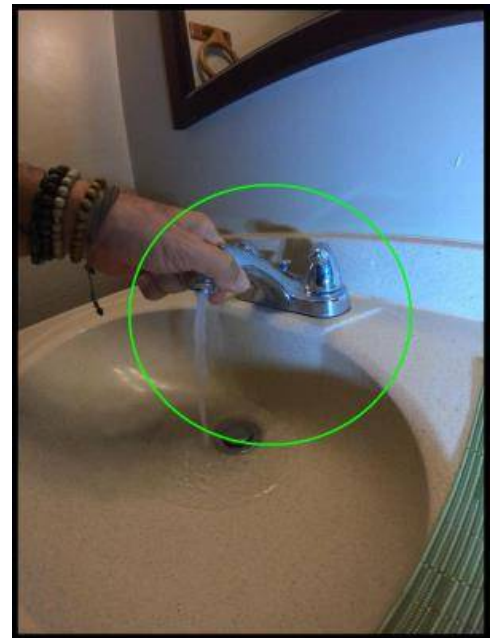
- **REPAIR or REPLACE** - the sink faucet and/or spigot in this bathroom is loose at the base and should be secured,
IMPLICATIONS Mechanical Failure,
TASK Repair or Replace
TIME As Soon As Possible

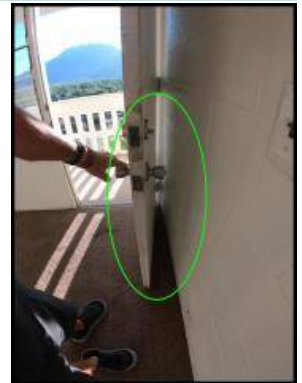
Serviceable - The main entry door to the structure is in functional condition.
There is a deadbolt installed on the main entry door
The guest at the front door is not readily visible. Installation of a viewing lens in the door would be a beneficial safety feature.
Missing door bumpers may cause or be causing damage to adjacent walls and/or doors.
Predictable weathering, wear and tear are noted.

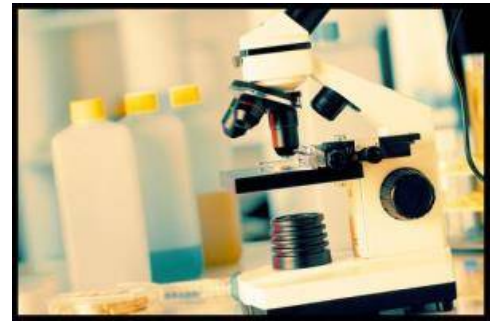
ADVISORY Structures built prior to the mid 1980s may contain lead and/or asbestos. Lead is commonly found in paint and in some plumbing components. Asbestos is commonly found in various building materials such as insulation, siding, and/or floor and ceiling tiles. Laws were passed in 1978 to prohibit usage of lead and asbestos, but stocks of materials containing these substances remained in use for a number of years thereafter. Both lead and asbestos are known health hazards. Evaluating for the presence of lead and/or asbestos is beyond the scope of this inspection. Any mention of these materials in this report is made as a courtesy only, and meant to refer the client to a specialist. Consult with specialists as necessary, such as industrial hygienists, professional labs and/or abatement specialists for this type of evaluation.

IMPLICATIONS Age related conditions, Unknown or Unseen Conditions May Exist

TASK If this is a concern for you, you may wish to consult with an expert in this field for more information or testing

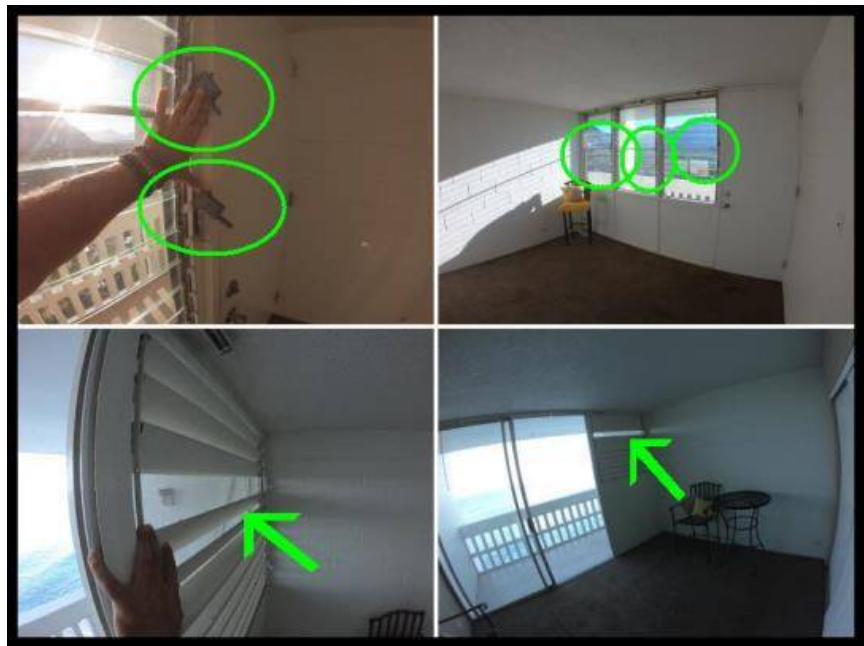
802.1 Window Concerns

- REPAIR or REPLACE** Jalousie window hardware needs repair or replacement; Components appear older damaged and or unreliable. Missing slat in bedroom. Missing and damaged cranks
LOCATION Throughout the Unit
IMPLICATIONS Age Related Conditions; Indicates older or worn component, Difficult to operate or not operational
TASK Repair or Replace Older or Worn Components or Parts
TIME As Soon As Possible

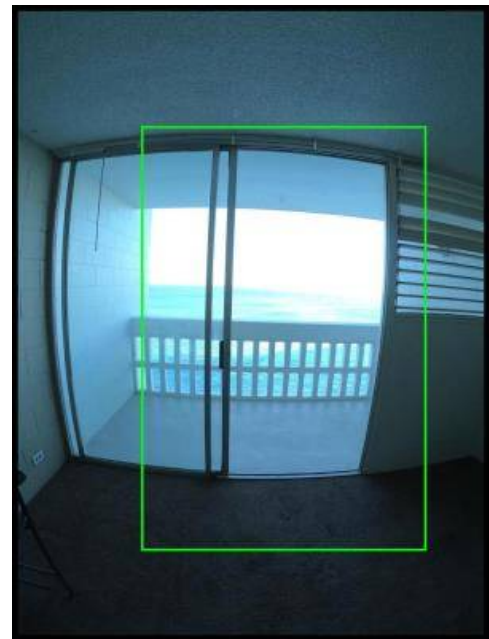
805.1 Screen Door Concerns

- ADVISORY No screens installed** - Screens missing or removed from at least one window in this room, recommend replace.
LOCATION Bedroom
IMPLICATIONS Missing or Removed Parts or Components
TASK Budget for Replacement
TIME As Required

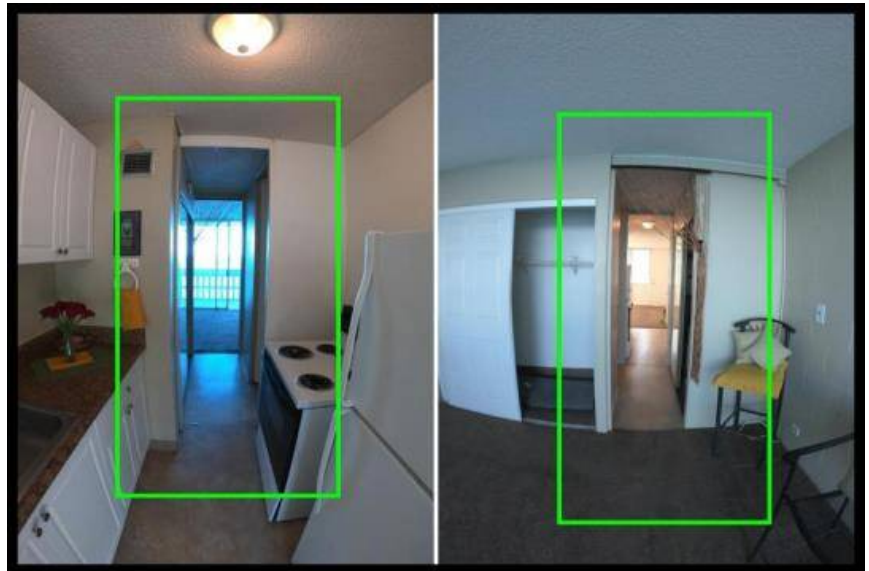
806.1 Interior Door Concerns

- **ADVISORY** At least one door appears to have been removed from this room. You may want to replace it at some point.
LOCATION Bedroom & Hall
IMPLICATIONS Missing or removed part or component, May not meet client expectations
TASK Consult sellers for more information regarding this concern, Budget for Replacement
TIME As Needed, Discretionary

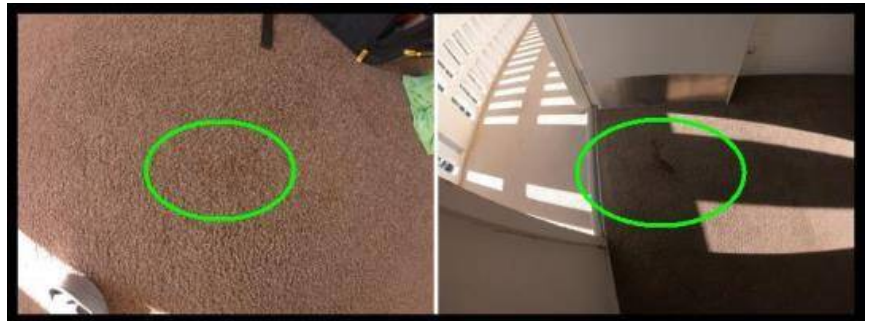
811.10 Carpet Floor Concerns

- **MARGINAL** Carpets are stained and should be evaluated for service or replacement, or whatever you think best.
LOCATION Living room & bedroom
IMPLICATIONS Cosmetic Defects
TASK Budget for Upgrades and/or Replacement
TIME As Required, Discretionary

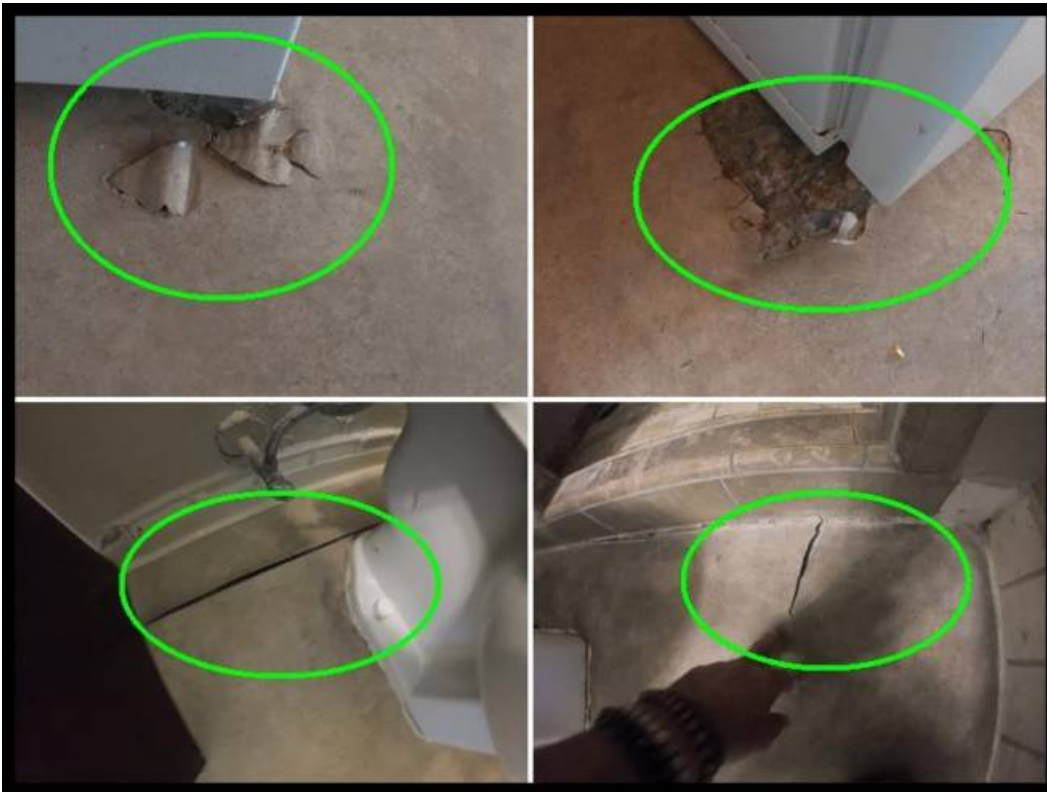
811.20 Vinyl Floor Concerns

- **MARGINAL** Damage to floors may include due to heavy objects being dragged across floors, impact damage, lifting or burns. We aren't worried about cosmetics but are interested in performance issues
LOCATION Kitchen & Bathroom
IMPLICATIONS Cosmetic Defects, Damaged Components
TASK Further Evaluation by an Appropriate Expert or Contractor For Repairs/Updates and Costs
TIME As Soon As Possible

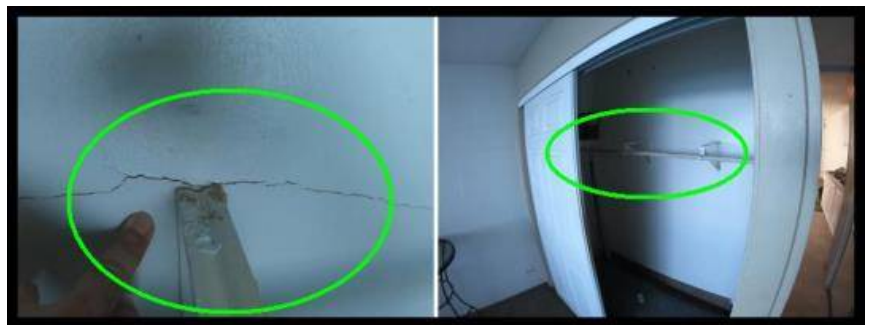
812.1 Wall Surface Concerns

- **REPAIR or REPLACE** There appears to be some minor damage to the wall in this closet; brackets pulling from structure?
LOCATION Bedroom Closet
IMPLICATIONS Mechanical Damage, No Structural Concern
TASK Repair or Replace Components and/or Parts
TIME As Soon As Possible or As Required
