Confidential Inspection Report

Prepared For: John & Susan Sample

123 Enikine Street

Honolulu, HI 96815

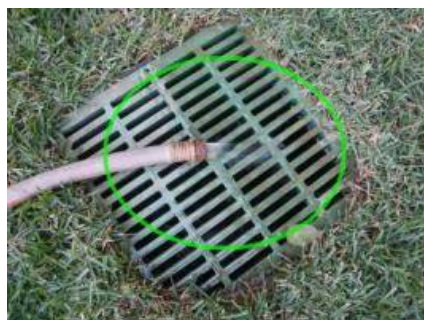
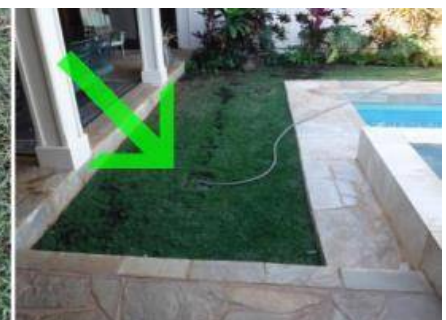
- **ADVISORY** ~ An area drain was observed and tested. It appears to be a French Drain at the middle yard. Downspouts appear to be connected to area drains as well
- **LOCATION** Various Areas of the Exterior
- **IMPLICATIONS** These are Widely Regarded Desirable Conditions,
- **TASK** Service Annually,
- **TIME** Ongoing.
